Update “With Site-Visit” Reserve Study

West Highlands Park Issaquah

Report #: 24841-3
For Period Beginning: July 1, 2016
Expires: June 30, 2017
Date Prepared: January 18, 2016

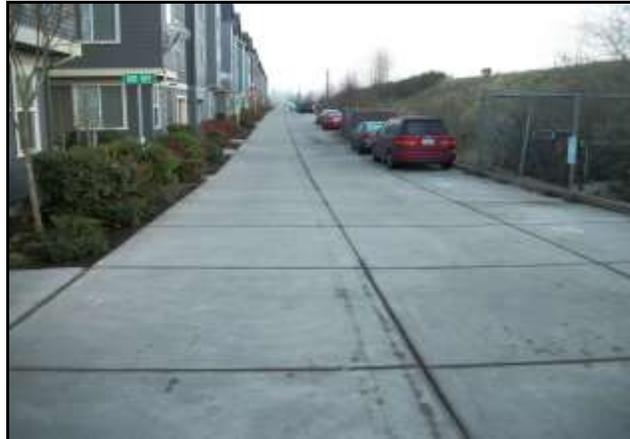
Useful Life:
5 years

Remaining Life:
1 years

Best Case: \$4,300

Worst Case: \$6,600

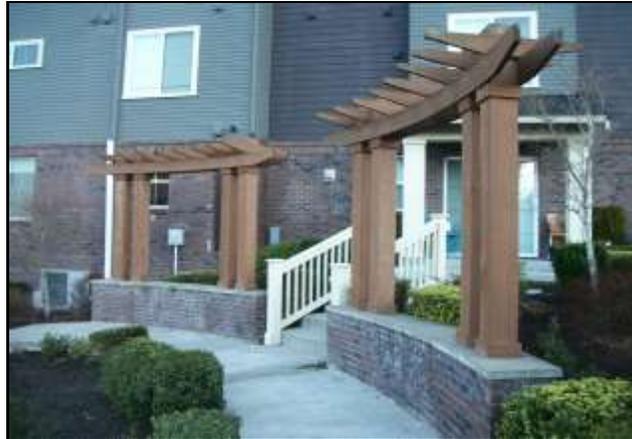
Useful Life:
15 years

Remaining Life:
10 years

Best Case: \$2,200

\$1,100/each (x2), Lower allowance to remove and replace

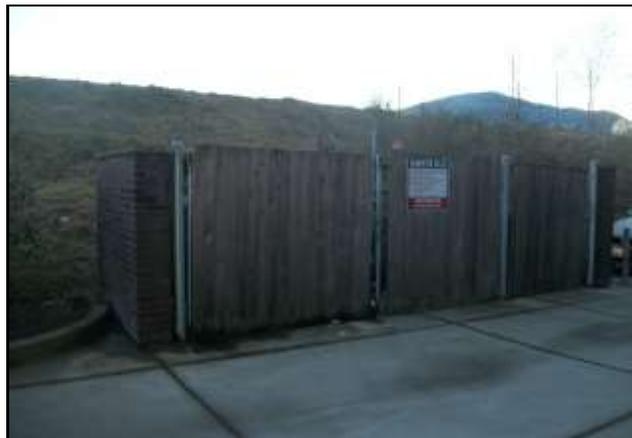
Useful Life:
15 years

Remaining Life:
10 years

Best Case: \$3,200

\$1,600/each (x2), Lower allowance for replacement of wood components

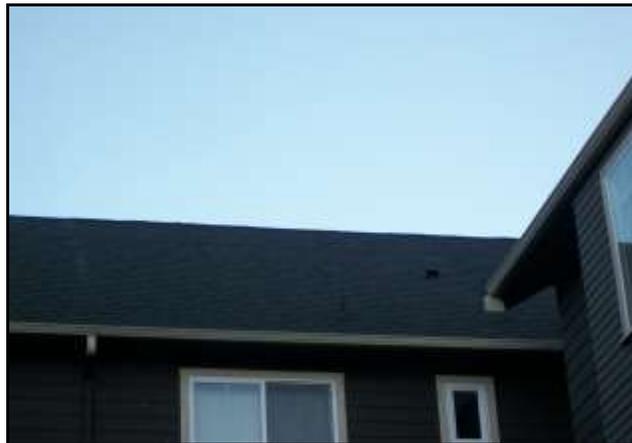
Useful Life:
25 years

Remaining Life:
20 years

Best Case: \$168,000

\$4/Sq Ft, Lower allowance to tear off and reroof

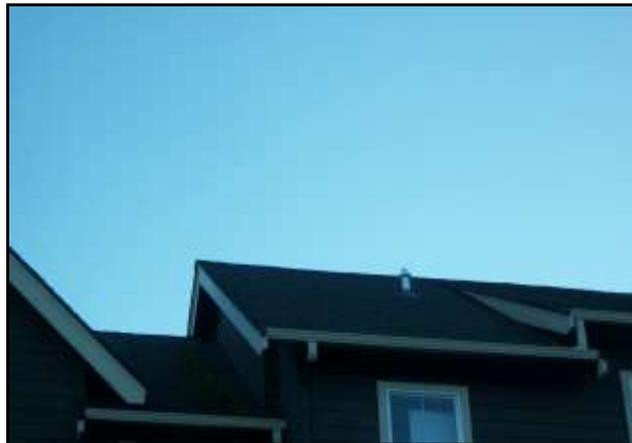
Useful Life:
3 years

Remaining Life:
0 years

Best Case: \$8,200

Worst Case: \$10,400

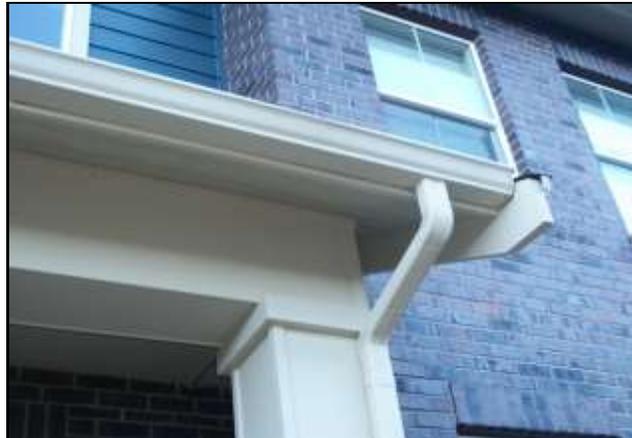
Useful Life:
25 years

Remaining Life:
20 years

Best Case: \$35,800

Worst Case: \$48,800

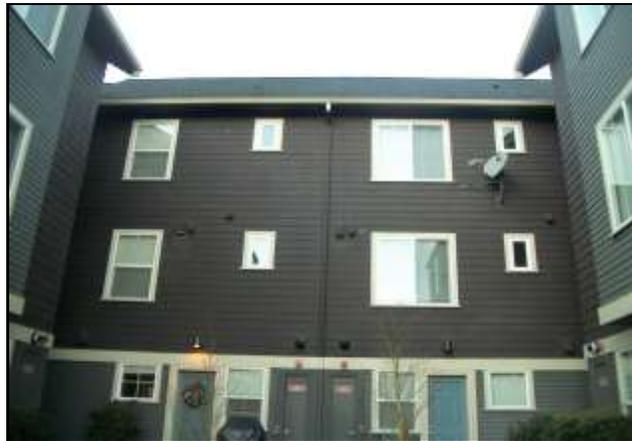
Useful Life:
50 years

Remaining Life:
45 years

Best Case: \$800,000

\$10/SF, Lower allowance to remove and replace siding/waterproofing

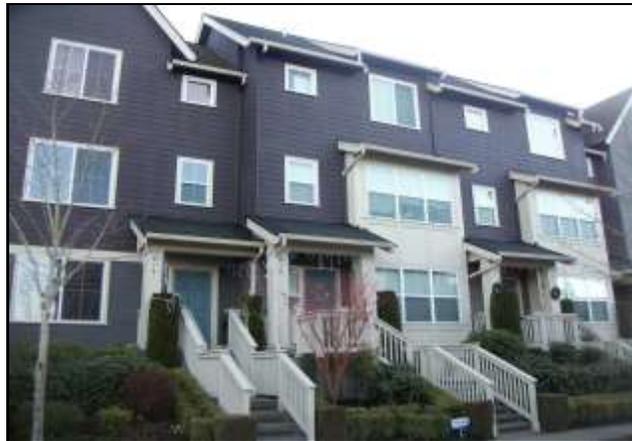
Useful Life:
8 years

Remaining Life:
3 years

Best Case: \$174,000

~\$3,100/unit (x56 units), Lower allowance for full paint project

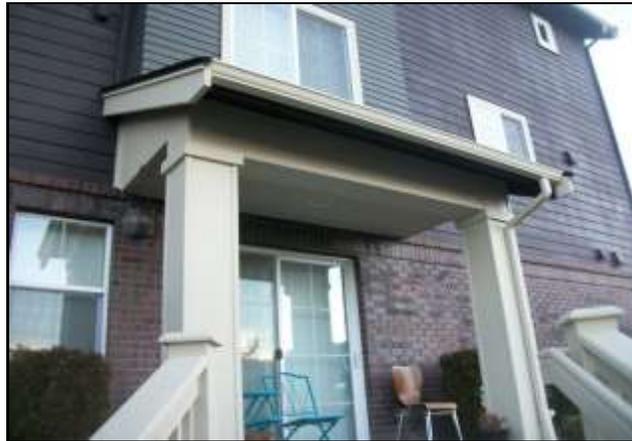
Useful Life:
8 years

Remaining Life:
7 years

Best Case: \$40,000

~\$700/unit (x56 units), Lower allowance for periodic partial paint projects between exhaustive projects

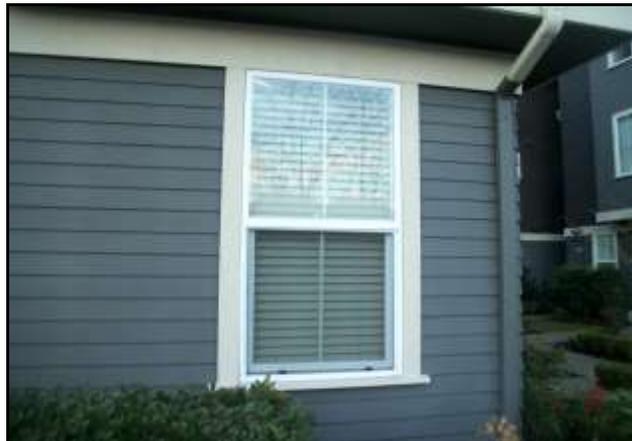
Useful Life:
4 years

Remaining Life:
1 years

Best Case: \$3,800

Worst Case: \$6,000

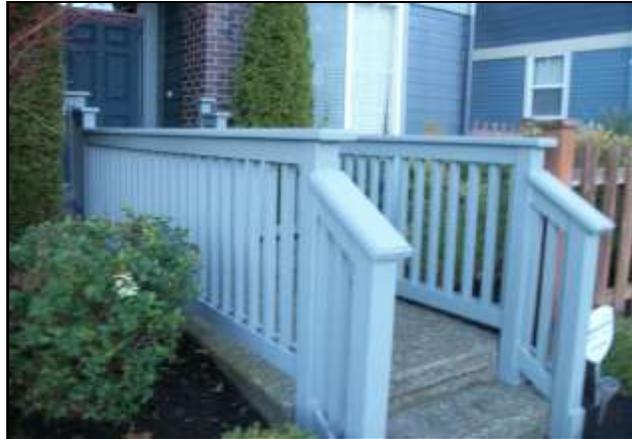
Useful Life:
24 years

Remaining Life:
19 years

Best Case: \$140,000

Worst Case: \$193,000

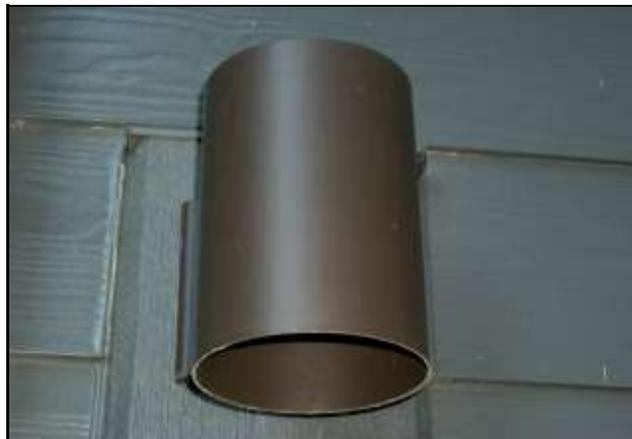
Useful Life:
24 years

Remaining Life:
19 years

Best Case: \$5,500

Worst Case: \$8,300

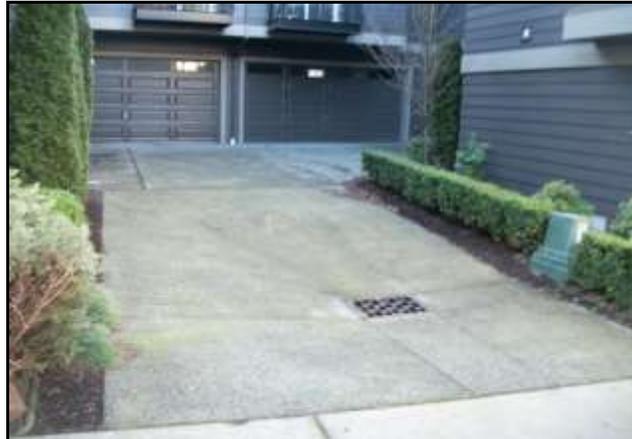
Useful Life:
5 years

Remaining Life:
2 years

Best Case: \$2,800

Worst Case: \$3,800

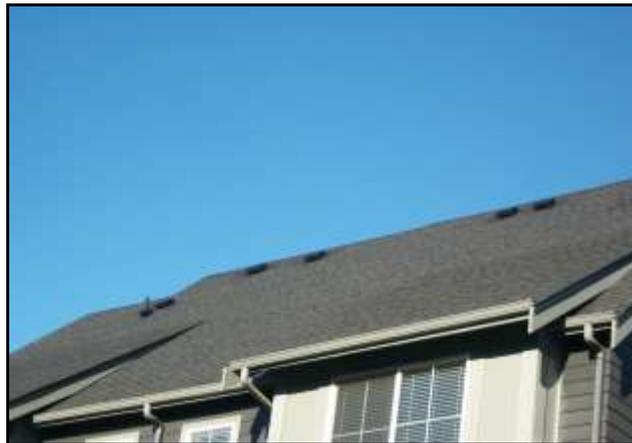
Useful Life:
25 years

Remaining Life:
21 years

Best Case: \$172,000

Worst Case: \$194,000

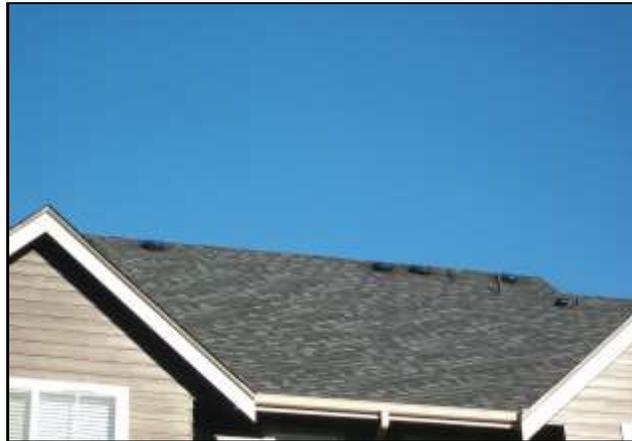
Useful Life:
3 years

Remaining Life:
0 years

Best Case: \$8,200

Worst Case: \$10,400

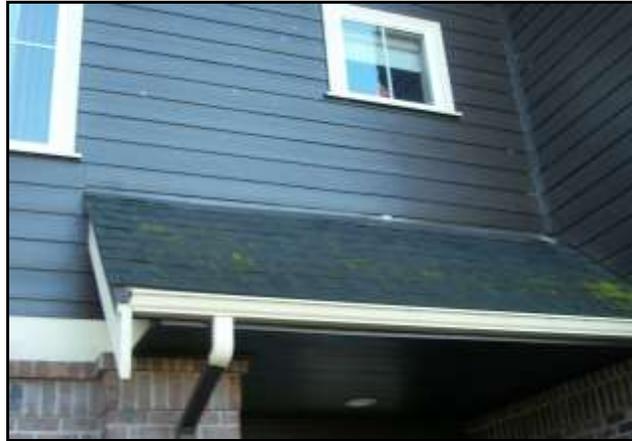
Useful Life:
25 years

Remaining Life:
21 years

Best Case: \$24,800

Worst Case: \$33,800

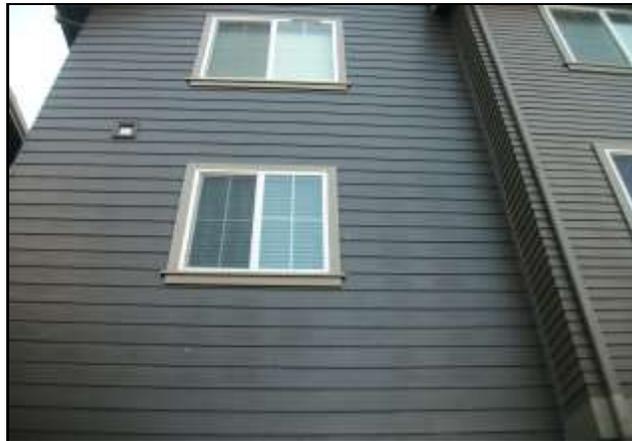
Useful Life:
50 years

Remaining Life:
46 years

Best Case: \$840,000

\$10/SF, Lower allowance to remove and replace siding and waterproofing

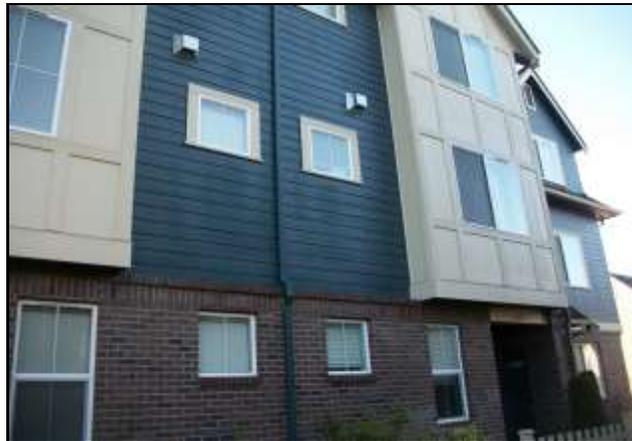
Useful Life:
8 years

Remaining Life:
4 years

Best Case: \$149,000

\$3,100/unit (x48 units), Lower allowance for full paint project

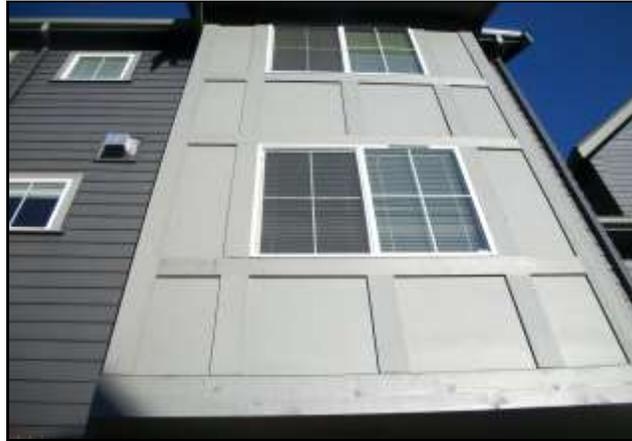
Useful Life:
8 years

Remaining Life:
0 years

Best Case: \$33,600

\$700/unit (x48 units), Lower allowance for partial paint/caulk (wood, more exposed areas, etc)

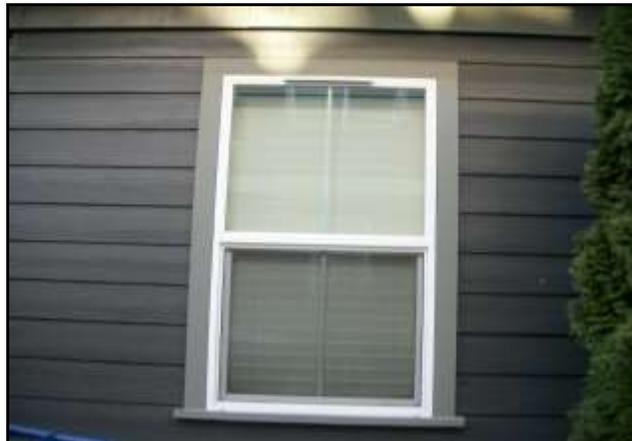
Useful Life:
4 years

Remaining Life:
2 years

Best Case: \$3,800

Worst Case: \$6,000

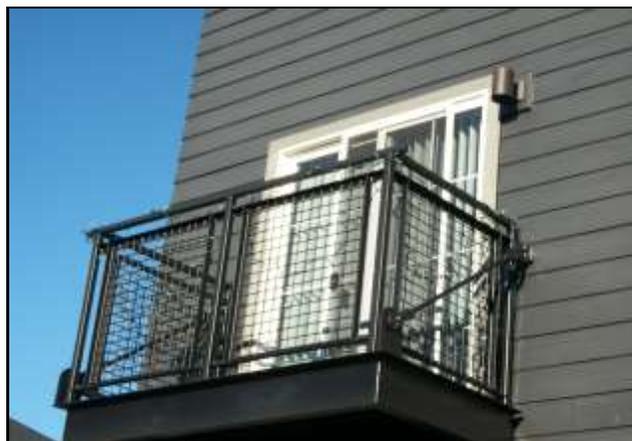
Useful Life:
16 years

Remaining Life:
12 years

Best Case: \$3,500

Worst Case: \$5,300

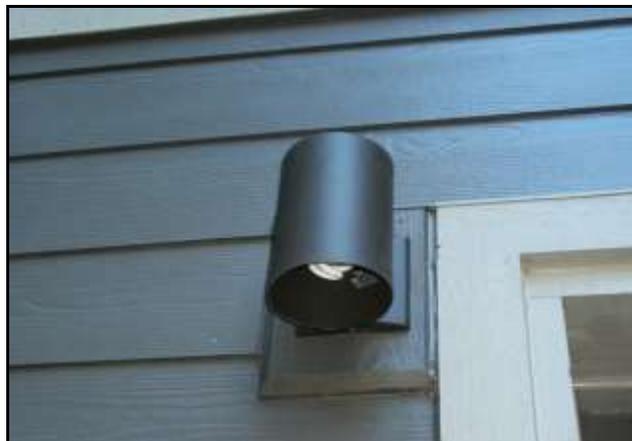
Remaining Life:

20 years

Best Case: \$5,500

Worst Case: \$8,300

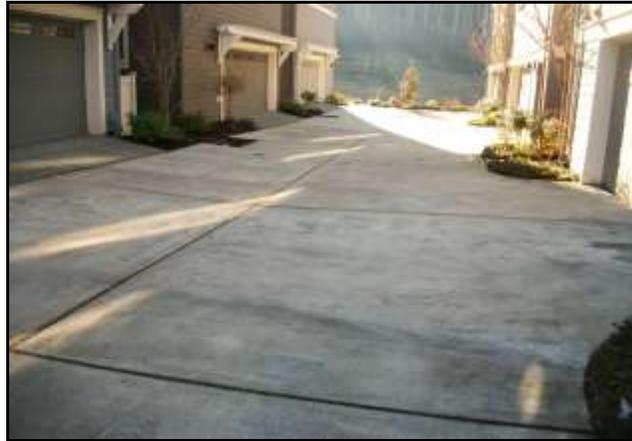
Useful Life:
5 years

Remaining Life:
1 years

Best Case: \$3,300

Worst Case: \$5,500

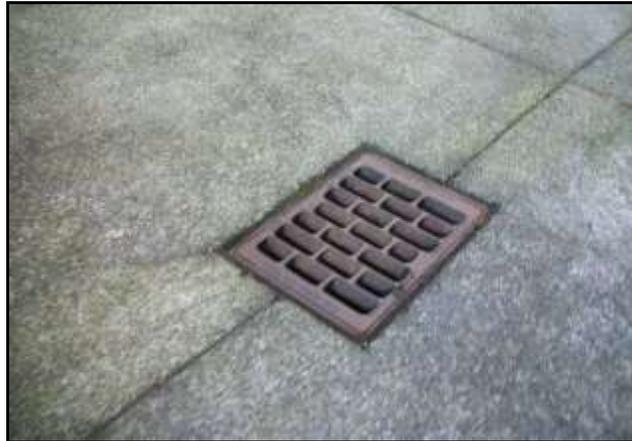
Useful Life:
5 years

Remaining Life:
2 years

Best Case: \$7,200

Worst Case: \$8,300

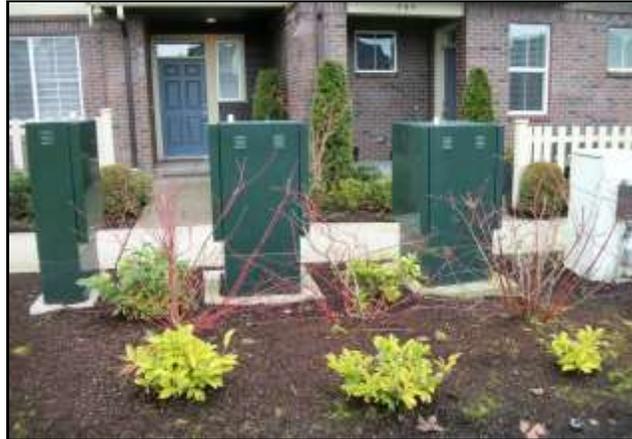
Useful Life:
20 years

Remaining Life:
16 years

Best Case: \$8,800

\$1,100/each (x4) for ET Managers & flow sensors plus
\$1,100/each (x4) for controllers, Lower estimate to
replace
