Update “With Site-Visit” Reserve Study

Crofton at Vg Grn, Div. 48 & 52 **Issaquah, WA**

Report #: 21574-4
For Period Beginning: July 1, 2016
Expires: June 30, 2017

Date Prepared: January 25, 2016

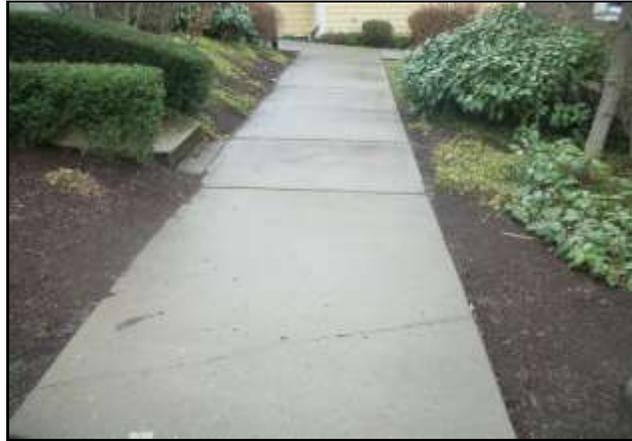
Useful Life:
5 years

Remaining Life:
1 years

Lower allowance for repairs/replacement

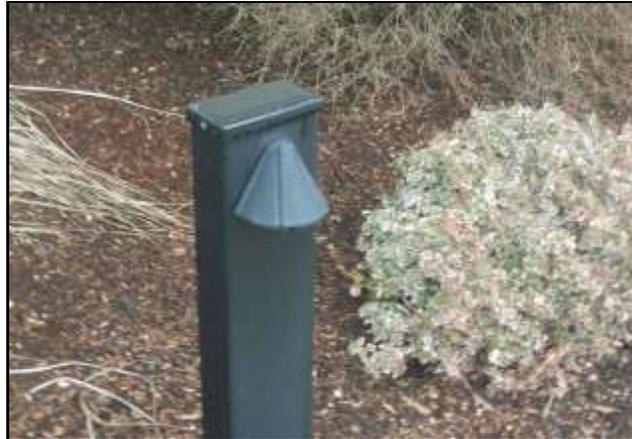
Comp # : 165 Path/Site Lights - Replace

Useful Life:
20 years

Remaining Life:
14 years

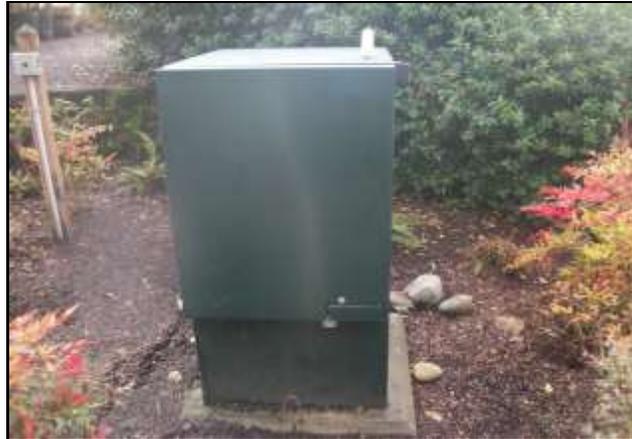
Useful Life:
4 years

Remaining Life:
0 years

Lower allowance for periodic repairs/replacement of irrigation power system components

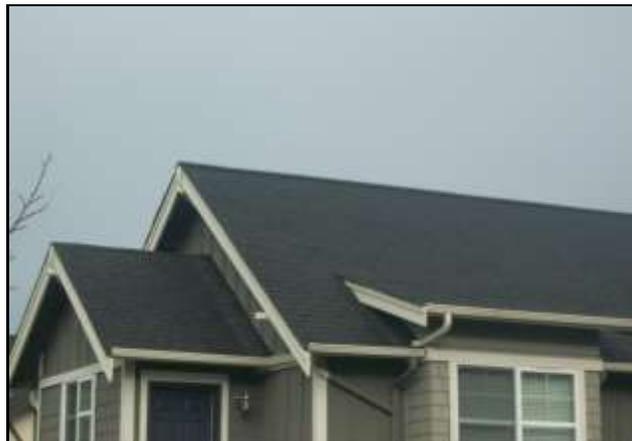
Useful Life:
25 years

Remaining Life:
14 years

\$3.50/Sq Ft, Lower allowance to tear off and reroof

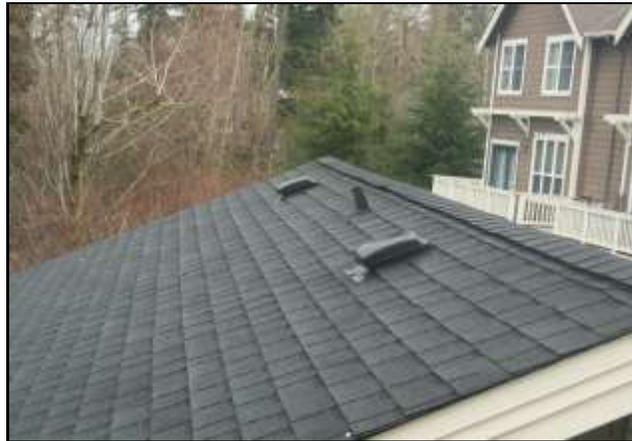
Useful Life:
3 years

Remaining Life:
0 years

Lower estimate to inspect, clean, repair and apply moss treatment

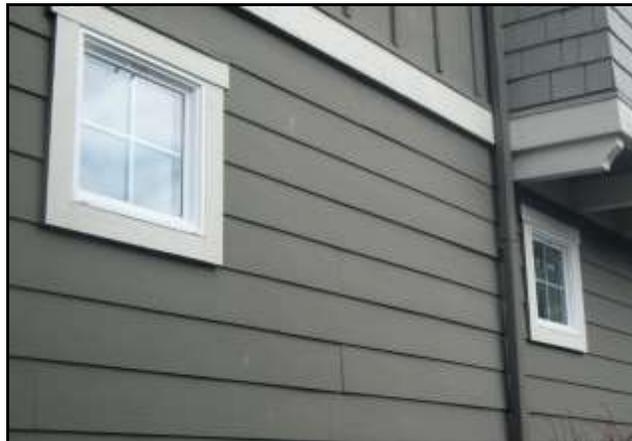
Useful Life:
50 years

Remaining Life:
42 years

\$10/SF, Lower allowance to remove and replace siding

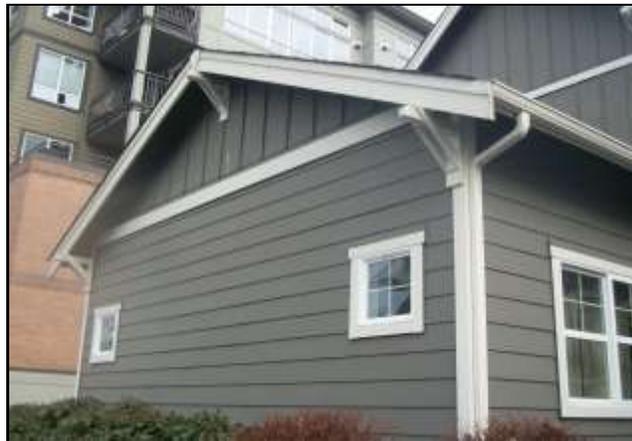
Useful Life:
8 years

Remaining Life:
2 years

\$1,500/unit (x56 units), Lower allowance for full paint project

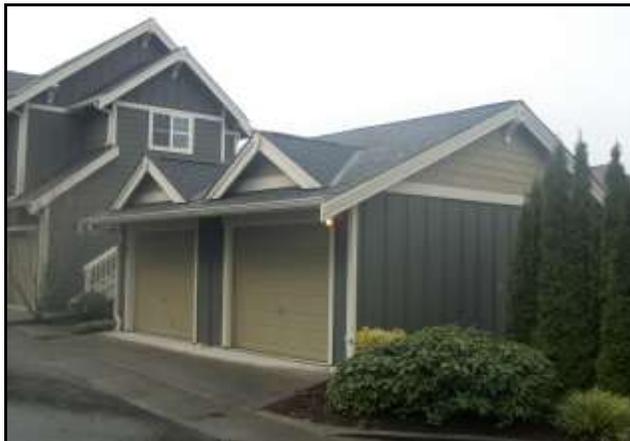
Useful Life:
8 years

Remaining Life:
6 years

\$550/unit (x56 units), Lower allowance to paint trim areas including decks, awnings, belly bands, etc.

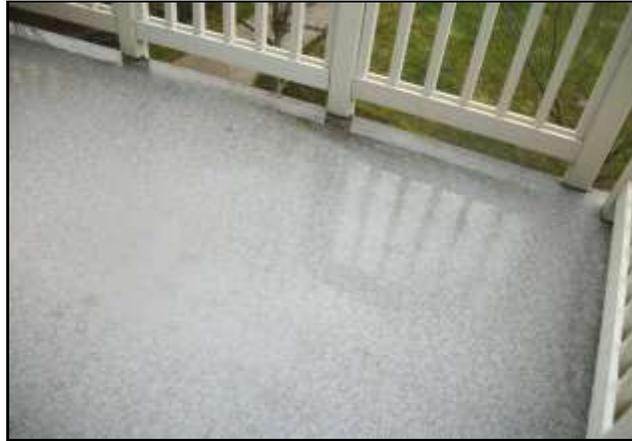
Useful Life:
20 years

Remaining Life:
9 years

\$15/Sq Ft, Lower allowance to remove and replace membrane

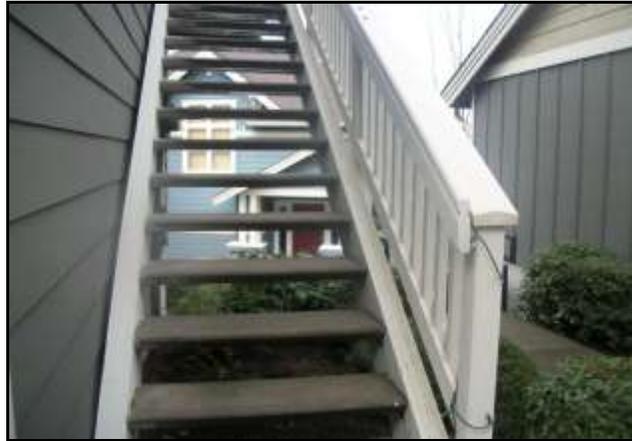
Useful Life:
24 years

Remaining Life:
13 years

\$2,700/assembly (x13), Lower allowance to repair/replace as-necessary

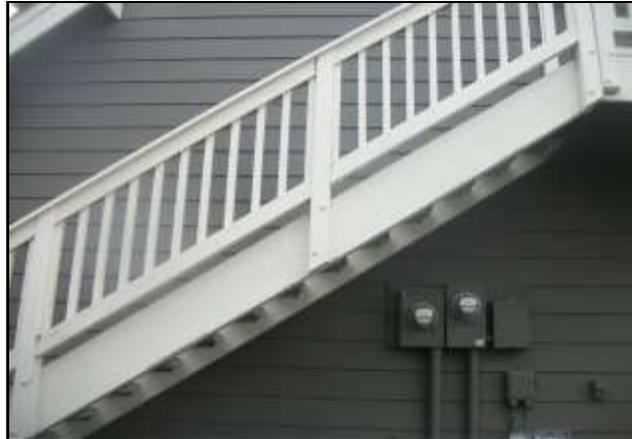
Useful Life:
24 years

Remaining Life:
13 years

Best Case: \$21,200
\$45/LF, lower allowance to replace

Worst Case: \$25,900
\$55/LF, higher allowance, upgrade materials, style, etc.

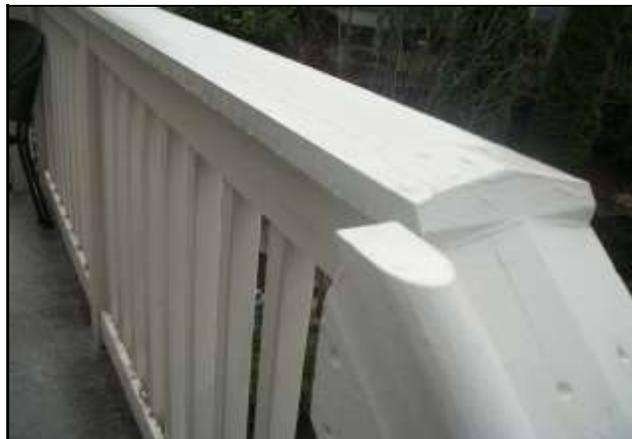
Useful Life:
5 years

Remaining Life:
0 years

Best Case: \$2,000
Lower allowance for touch-up/paint of railings

Worst Case: \$4,000
Higher allowance
