## “Full” Reserve Study

## Sunset Walk Neighborhood Issaquah, WA

**Report #: 28590-0**  
**For Period Beginning: July 1, 2016**  
**Expires: June 30, 2017**

**Date Prepared: January 28, 2016**

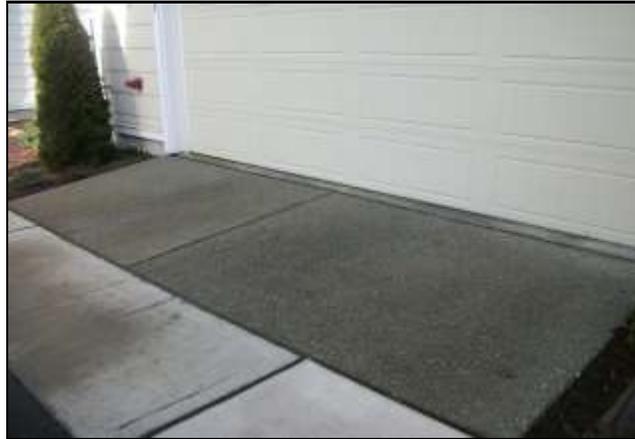
**Comp # : 100      Driveways, Sidewalks - Repr/Replace**

Useful Life:  
5 years

Remaining Life:  
7 years

Best Case: \$3,000

Worst Case: \$5,000

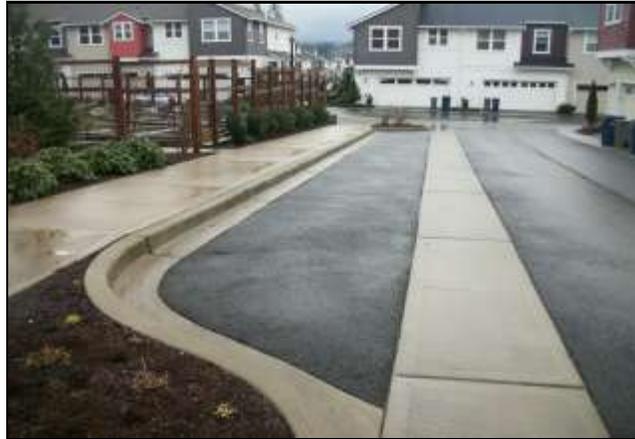
Useful Life:  
25 years

Remaining Life:  
22 years

Best Case: \$2,600

Worst Case: \$3,900

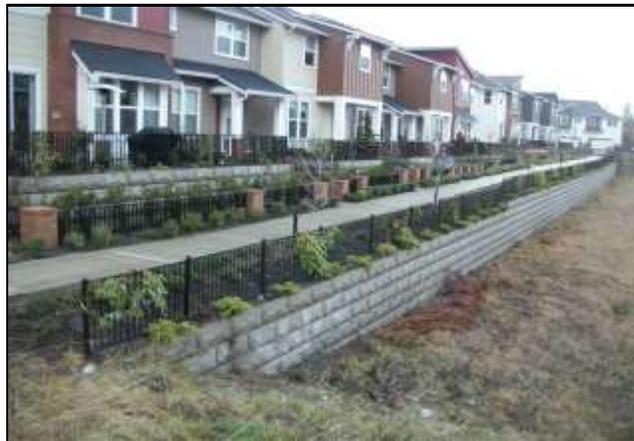
Useful Life:  
40 years

Remaining Life:  
37 years

Best Case: \$113,000

Worst Case: \$146,000

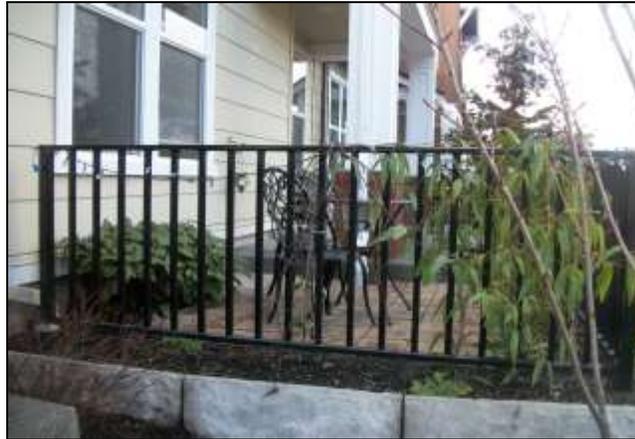
Useful Life:  
10 years

Remaining Life:  
7 years

Best Case: \$22,500

Worst Case: \$33,800

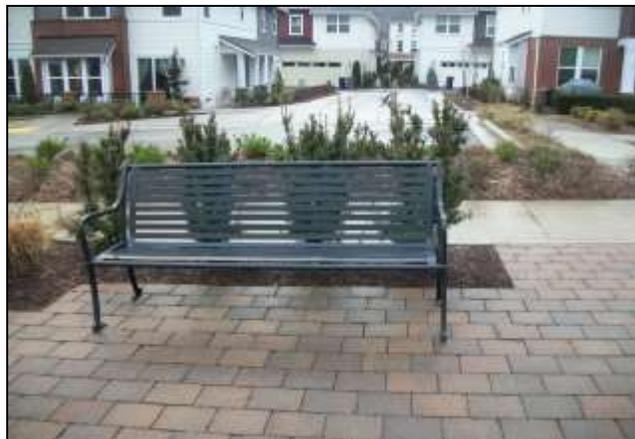
Useful Life:  
20 years

Remaining Life:  
17 years

Best Case: \$2,500

Worst Case: \$3,500

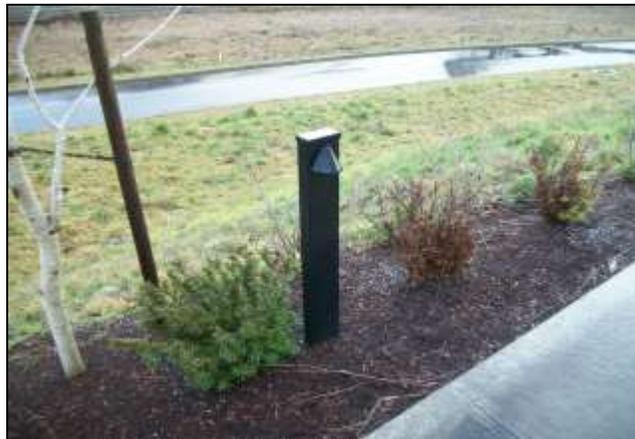
Useful Life:  
20 years

Remaining Life:  
17 years

Best Case: \$3,900

Worst Case: \$7,800

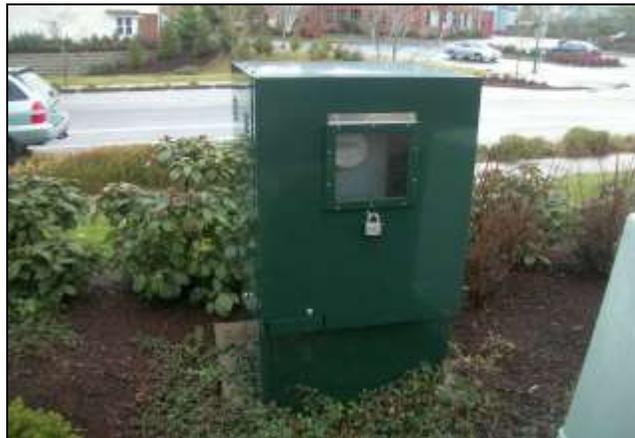
Remaining Life:

12 years

Best Case: \$5,000

Worst Case: \$7,000

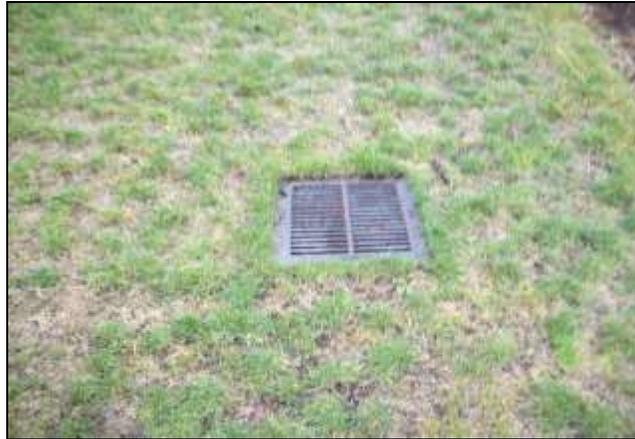
Useful Life:  
5 years

Remaining Life:  
2 years

Best Case: \$4,000

Worst Case: \$6,000

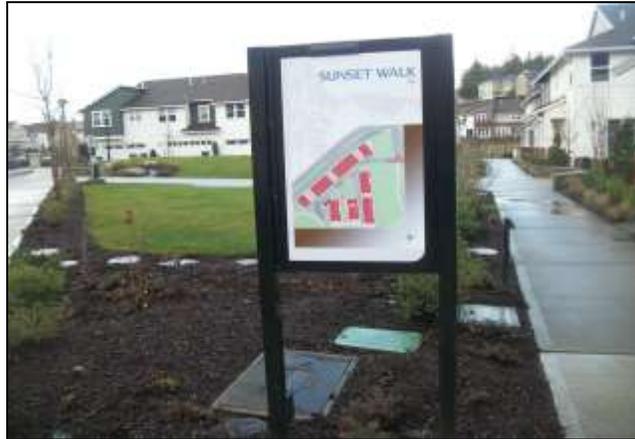
Useful Life:  
20 years

Remaining Life:  
17 years

Best Case: \$3,500

Worst Case: \$5,300

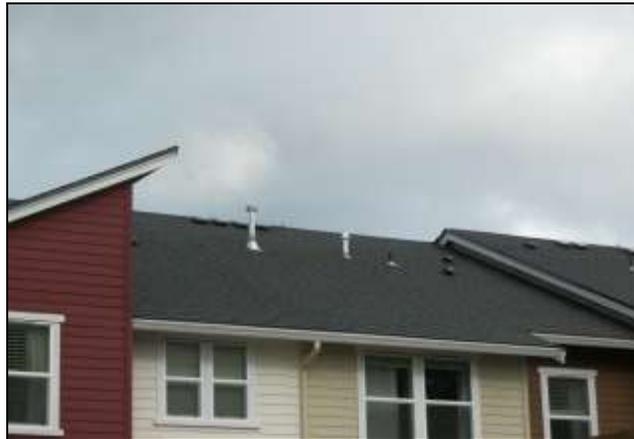
Useful Life:  
25 years

Remaining Life:  
22 years

Best Case: \$350,000

\$3.50/Sq Ft, Lower allowance to tear off and reroof

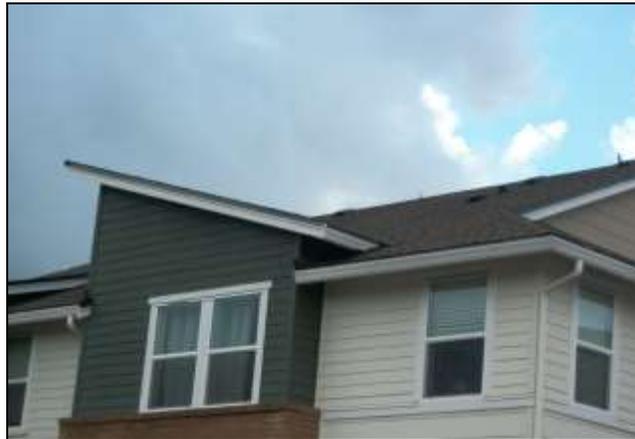
Useful Life:  
3 years

Remaining Life:  
1 years

Best Case: \$8,000

Worst Case: \$12,000

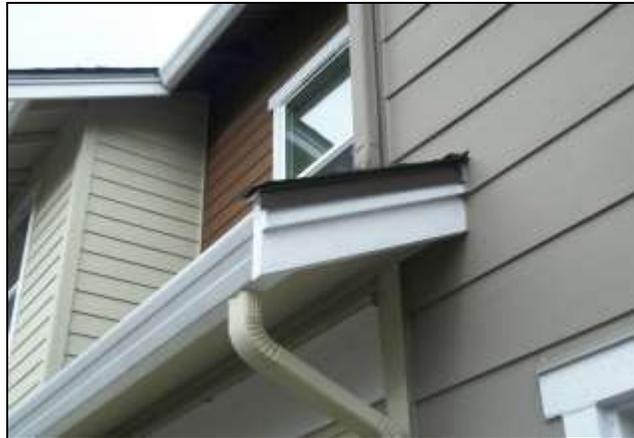
Useful Life:  
25 years

Remaining Life:  
22 years

Best Case: \$46,500

Worst Case: \$65,100

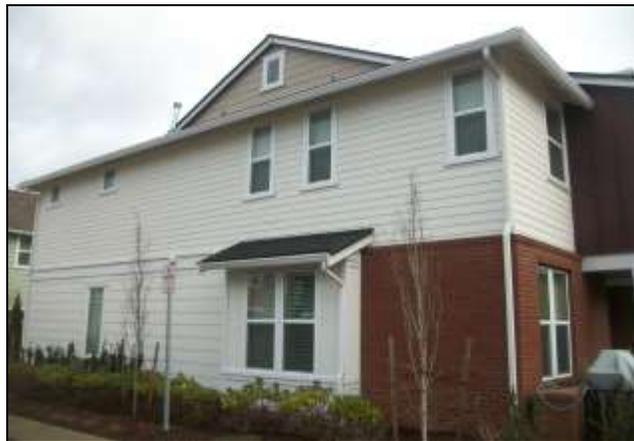
Useful Life:  
50 years

Remaining Life:  
47 years

Best Case: \$900,000

Worst Case: \$1,350,000

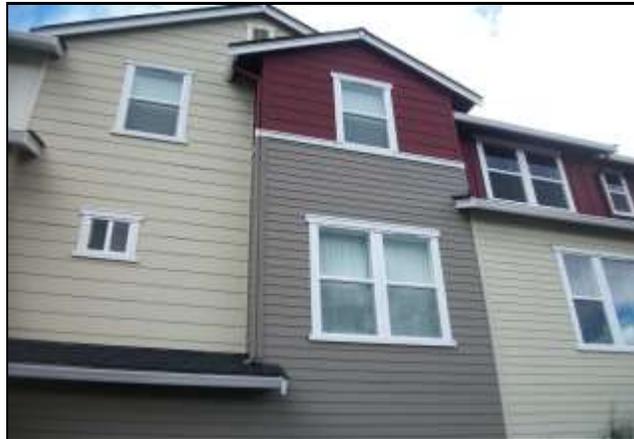
Useful Life:  
8 years

Remaining Life:  
5 years

Best Case: \$158,000

\$1.75/SF, Lower allowance to paint entire building exterior surfaces including caulking

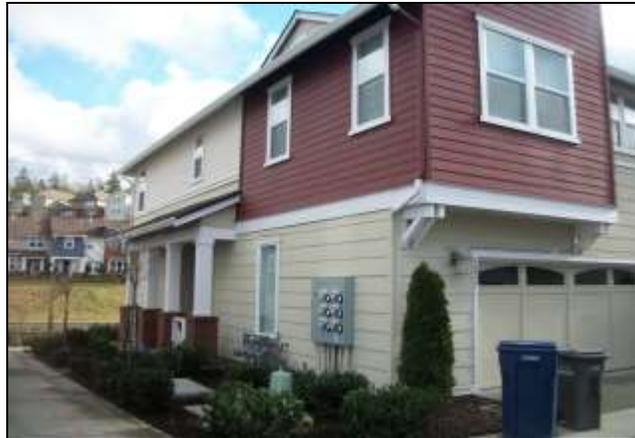
Useful Life:  
8 years

Remaining Life:  
3 years

Best Case: \$40,000

Worst Case: \$50,000

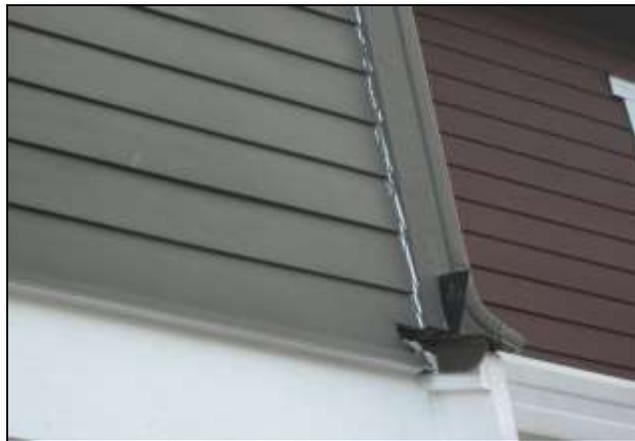
Useful Life:  
8 years

Remaining Life:  
1 years

Best Case: \$6,000

Worst Case: \$10,000
