“Full” Reserve Study

View Ridge Neighborhood Issaquah, WA

Report #: 28682-0
For Period Beginning: July 1, 2016
Expires: June 30, 2017

Date Prepared: January 25, 2016

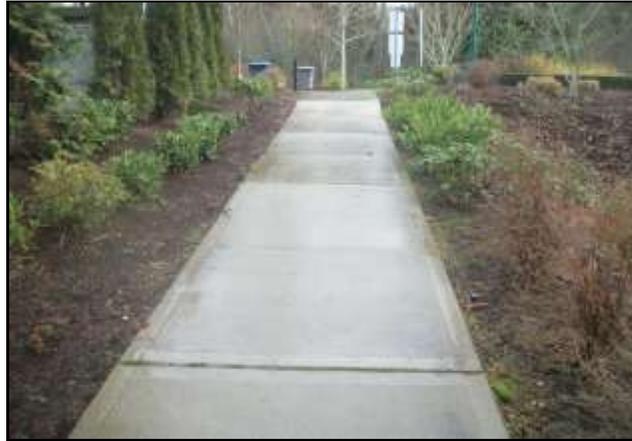
Comp # : 100 Sidewalks, Driveways - Repr/Replace Quantity: Poured in place

Evaluation : No widespread or significant cracking or damage noted of concrete. Repair any trip and fall hazards (1/2" or larger displacement) immediately to ensure safety. In our experience, larger repair/replacement expenses can emerge as the community ages. Although difficult to predict timing, cost and scope, we suggest a funding allowance to supplement the operating/maintenance budget for periodic, larger repairs. The timing here is set to start at about when the community is about 10 years old. Adjust as conditions, actual expense history dictates within future reserve study updates. As routine maintenance, inspect regularly, pressure wash for appearance and repair promptly as needed to prevent water penetrating into the base and causing further damage. Monitor tree roots nearby; consult with arborist for best practice.

Lower allowance for periodic local repairs/replacement

Higher allowance; more repair needs

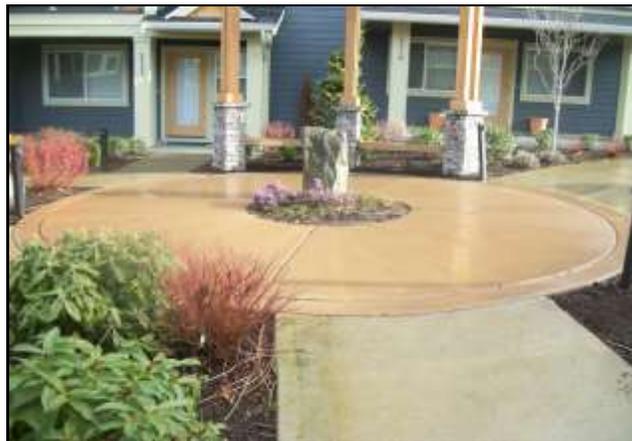
Comp # : 105 Plaza Concrete - Repair/Replace Quantity: Colored pad, bench

Funded? : No - Useful life is not predictable; repair/replace as needed out of operating budget

Evaluation : There is a circular concrete plaza pad with colored concrete surface; adjacent concrete bench adjoins this area. With ordinary care and maintenance (cleaning/locally repairing), no predictable basis for major repairs/replacement assuming designed and installed correctly. No basis for reserve funding.

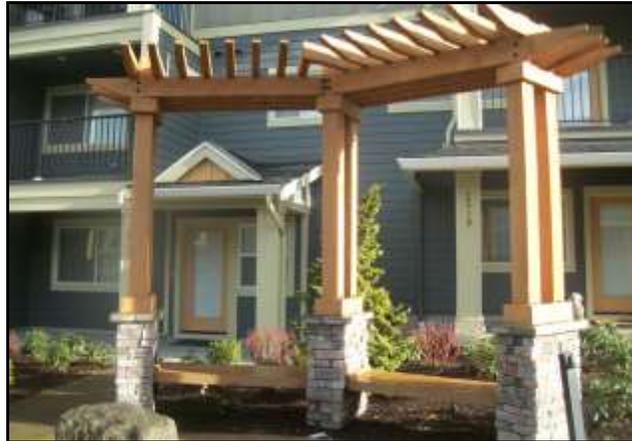
Comp # : 107 Plaza Trellis - Repair/Replace

Evaluation : Wood trellis has three wood posts set in stone columns and two benches spanning between columns. No significant deterioration or damage was observed. Expect to replace wood at roughly the time frame shown below due to typical exposure. Evaluate as remaining useful life approaches zero years and adjust life accordingly. Inspect periodically and repair as needed. Clean and paint/stain as needed as part of routine maintenance.

Lower allowance to replace wood portion of trellis structure, including benches

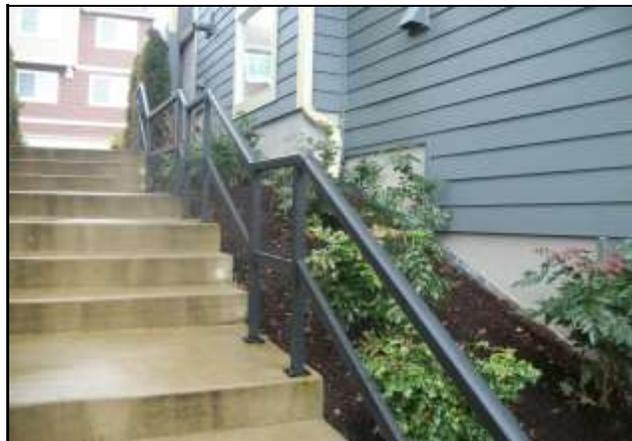
Comp # : 112 Metal Handrails - Repair/Replace

Evaluation : No obvious instability or widespread damage to what appears to be powder coated, aluminum railings. Over time, these railings will deteriorate due to constant exposure and use/abuse over time. We suggest reserve funding for regular intervals of total replacement as indicated below. As routine maintenance, inspect regularly to ensure safety and stability; repair promptly as needed using general operating/maintenance funds.

\$50/LF, Lower allowance to remove and replace
