## Update “With-Site-Visit” Reserve Study

### Villaggio Neighborhood Issaquah, WA

**Report #: 21948-2**  
**For Period Beginning: July 1, 2013**  
**Expires: June 30, 2014**

**Date Prepared: February 19, 2013**

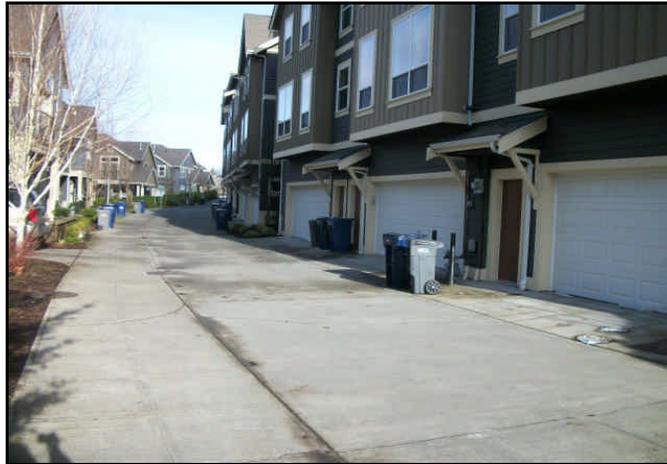
Evaluation: We noted soiled surfaces and some local cracking, however no widespread or significant damage/deterioration observed. Repair any trip and fall hazards (1/2" or larger displacement) immediately to ensure safety.

In our experience, larger repair/replacement expenses can emerge as the community ages. Although difficult to predict timing, cost and scope, we suggest a funding allowance to supplement the operating/maintenance budget for periodic, larger repairs. Adjust as conditions, actual expense history dictates within future reserve study updates.

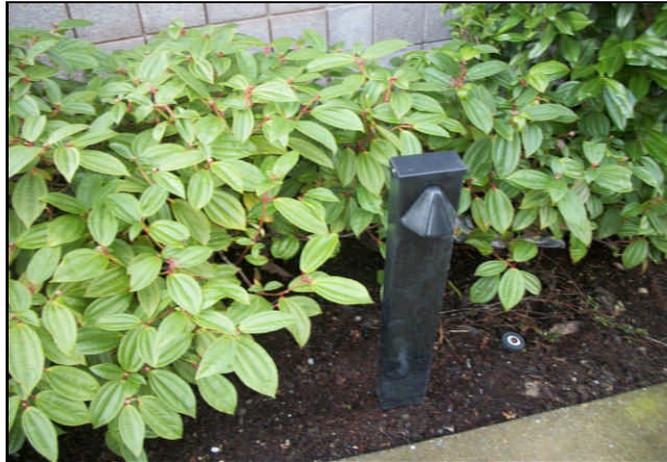
**Comp #:** 165 **Path/Site Lights - Replace**

Best to plan for replacement as shown here due to damage/deterioration that will result from constant exposure.

As routine maintenance, inspect regularly, clean for appearance and repair/change bulbs as needed.

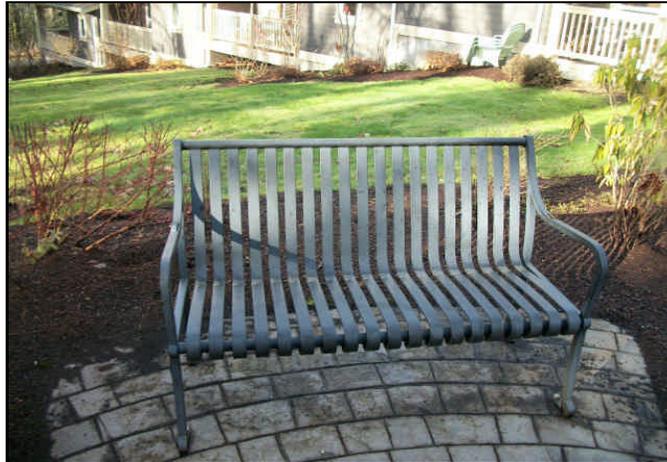
Although at one point will need to be replaced due to deterioration that will result from constant exposure, cost to replace this single bench best funded within annual operating budget, not long term reserve planning.

Inspect regularly, clean for appearance and repair as needed from general operating funds.

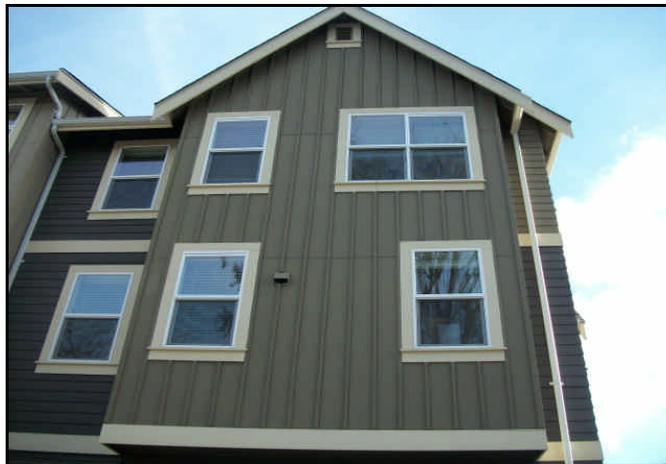
Buildings appear to be fiber-cement materials of lap and bat/board style; trim, fascia, door moldings, etc. are painted wood. Although we did not observe any significant or widespread problems/deterioration with siding, we noted some areas of the board/bath with wear/fading of surfaces. There was also an areas just below a metal Juliet balcony where the belly band trim was showing signs of rot/water intrusion. Actual manufacturer of siding was not confirmed since we conducted only a limited visual review. The largest manufacturer of fiber-cement siding is James Hardie Company (Hardie Siding). Currently Hardie offers the choice of a 30-year non-prorated or 50-year pro-rated warranty. In our discussion with local Hardie representative, suggestion is to plan for 50 year total service life which includes the underlying waterproofing which degrade over time and may require replacement.

Typically we would recommend planning for complete replacement of this type of siding and underlying waterproofing at the 50-year mark of life, however we are not including this large scale replacement funding in this study due to the vague wording as discussed above. However, at the request of the Association Management and based on our observation, a periodic allowance is included for repairs coinciding with paint projects. We recommend the Association consult with an attorney for definitive interpretation of the documents to clarify which siding components (siding, trim, waterproofing, etc.) if any, are Association responsibility and alter this component in future reserve studies if needed.

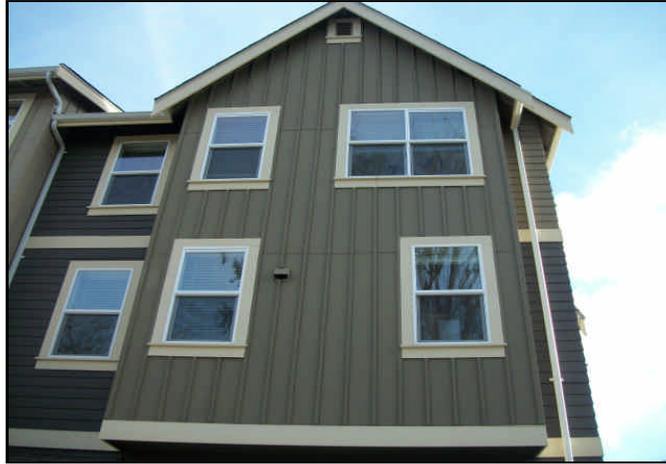
**Location:** Exterior walls

**Evaluation:** Windows were generally noted to be in good condition throughout the association. According to Governing Documents for Villaggio Neighborhood Article 3.1 (c) (iii), although the residential association is responsible for caulking of the exterior portions of all windows, "The Residential Association shall not be responsible for any maintenance or repairs to any ...window" (Article 3.1(i)). With this understanding, no funding for association repair/replacement however association should establish specific guidelines for repairs/replacements to ensure adequate waterproofing, consistent appearance, etc. throughout community. Note: funding for inspections/caulking within component #529.

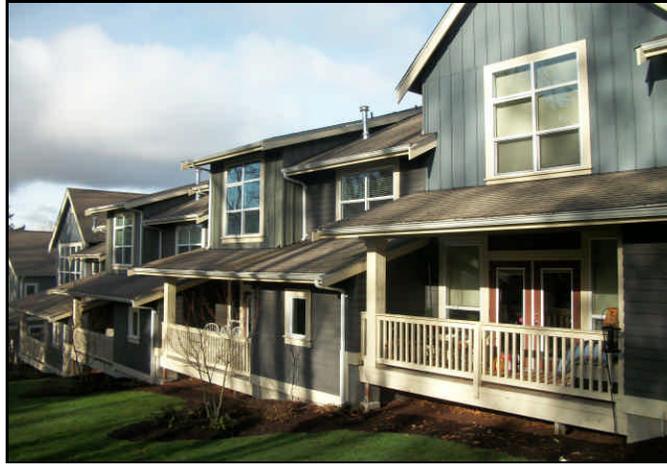
We suggest reserve funding for regular intervals of total replacement as indicated below. This component coincides with other deck component (#545) for cost efficiency/consistency.

As routine maintenance, inspect regularly to ensure safety and stability; repair promptly as needed using general operating/maintenance funds.

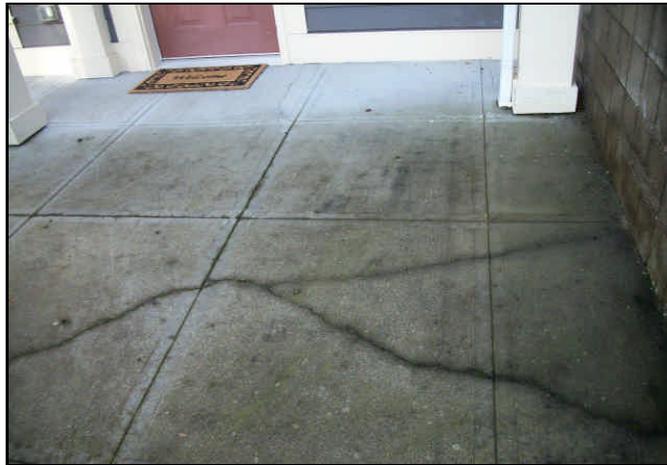
Although larger repair/replacement expenses can emerge as the community ages, at this time no predictable basis that this may be needed therefore no reserve funding included at this time.

As routine maintenance, inspect regularly, pressure wash for appearance and repair promptly as needed to prevent water penetrating into the base and causing further damage. Repair any trip and fall hazards (1/2" or larger displacement) immediately to ensure safety. Monitor tree roots nearby; consult with arborist for best practice.

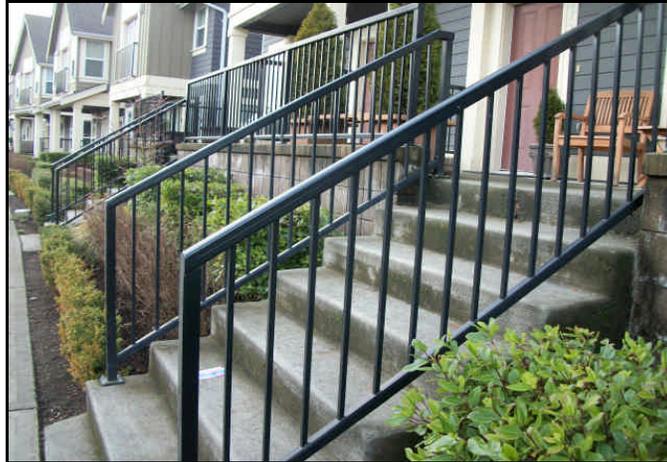
Over time, these railings will deteriorate due to constant exposure and use/abuse over time. We suggest reserve funding for regular intervals of total replacement as indicated below.

As routine maintenance, inspect regularly to ensure safety and stability; repair promptly as needed using general operating/maintenance funds.

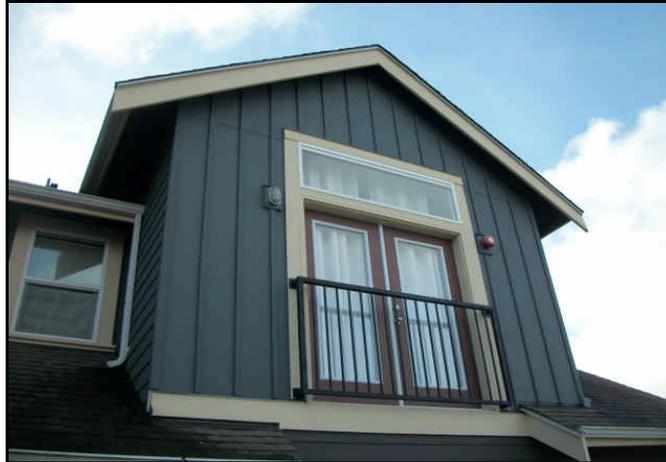
Best to plan for large scale replacement, best timed to coincide with exterior paint cycles (#525/#527), if possible, for cost efficiency and consistent quality/appearance throughout association. A mid-range replacement allowance is factored below for planning purposes.

As routine maintenance, inspect, repair/change bulbs as needed.

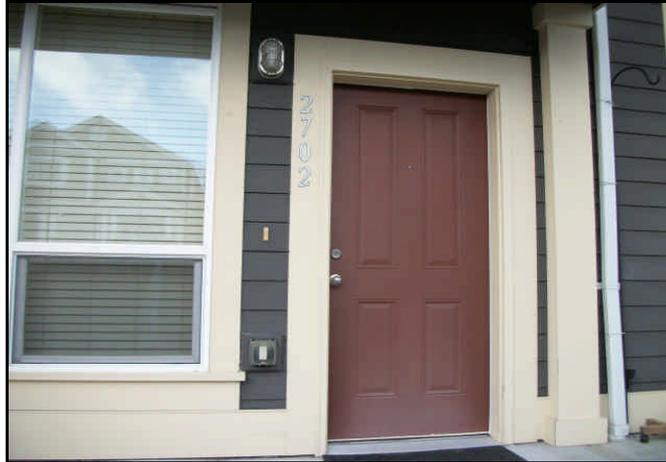
Location: Entries to units and garages

Evaluation: Stable condition of metal/aluminum garage doors and metal/glass entry/porch doors with no significant damage or deterioration observed. We assume installed without defect of material and/or workmanship. As with windows (#535), according to Governing Documents for Villaggio Neighborhood Article 3.1 (c) (iii), although the residential association is responsible for caulking of the exterior portions of all ..doors, "The Residential Association shall not be responsible for any maintenance or repairs to any ... door" (Article 3.1(i)). With this understanding, no funding for association repair/replacement however association should establish specific guidelines to provide to homeowners for repairs/replacements to ensure adequate waterproofing, consistent appearance, etc. throughout community. These door types should have long life.
