Update “With Site-Visit” Reserve Study

Concord Commons Issaquah, WA

Report #: 21947-4
For Period Beginning: July 1, 2016
Expires: June 30, 2017
Date Prepared: January 12, 2016

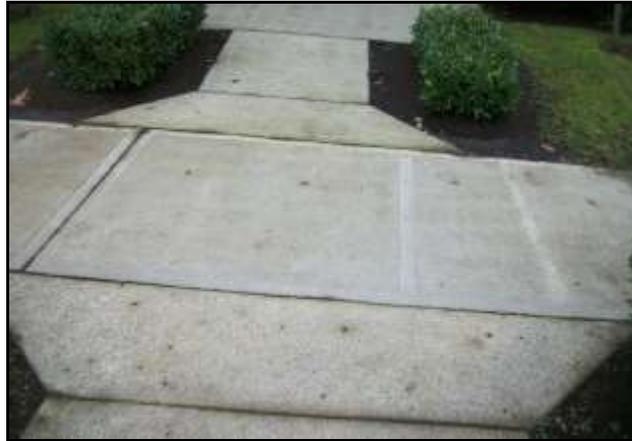
Comp # : 100 Concrete Dwys/Sdwks- Repr/Replace Quantity: Poured in place

Useful Life:
5 years

Remaining Life:
0 years

Lower allowance for periodic local repairs/replacement

Higher allowance; more repair needs

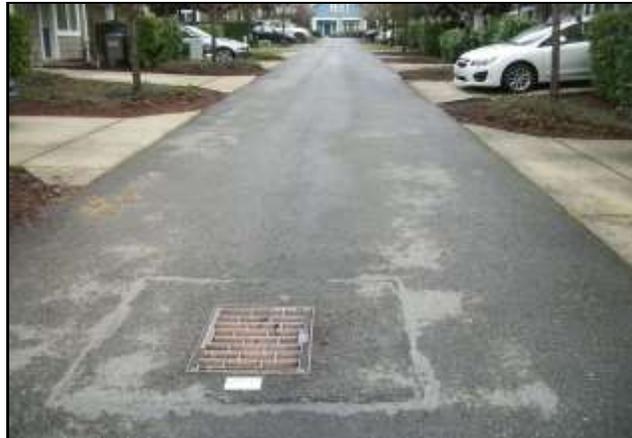
Useful Life:
30 years

Remaining Life:
19 years

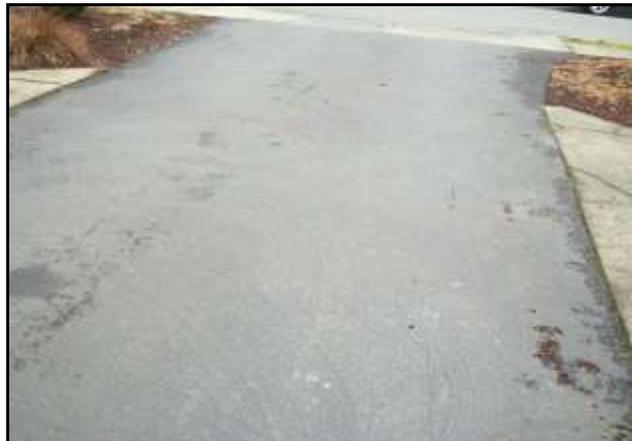
Useful Life:
5 years

Remaining Life:
0 years

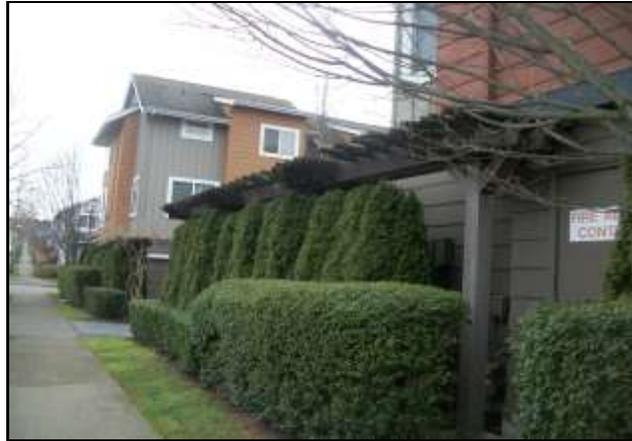
Useful Life:
20 years

Remaining Life:
8 years

\$2,200/each (x8), Lower allowance to remove and replace

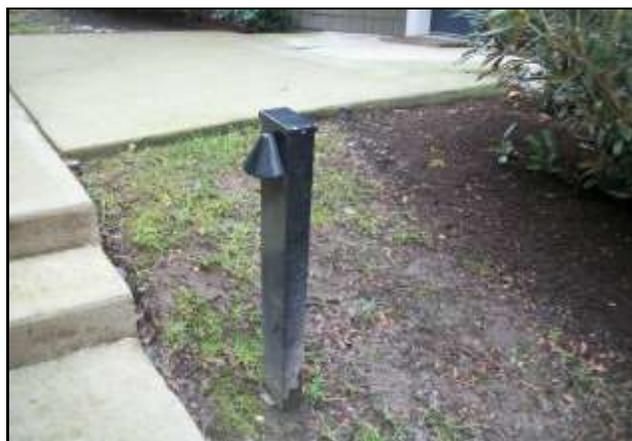
Useful Life:
20 years

Remaining Life:
15 years

\$165/each (x8), Lower allowance to replace

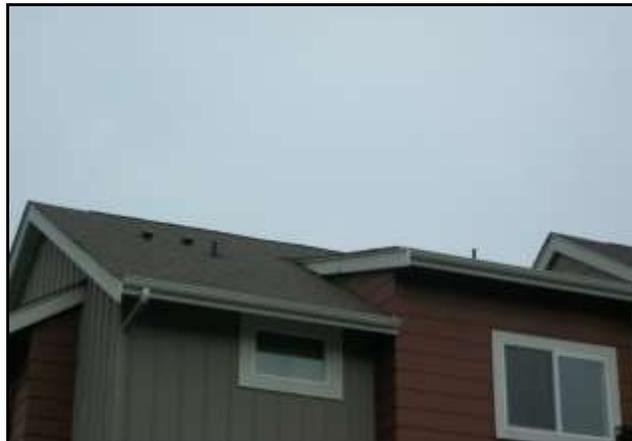
Useful Life:
25 years

Remaining Life:
13 years

\$4/Sq Ft, Lower allowance to tear off and reroof

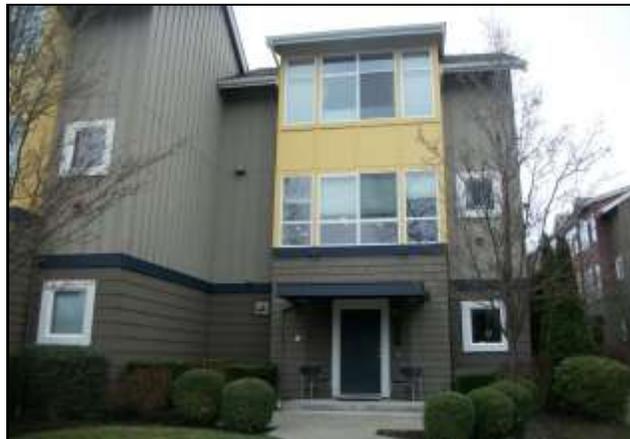
Useful Life:
8 years

Remaining Life:
3 years

\$1,300/unit (x48 units), Lower allowance to paint entire building exterior surfaces including caulking

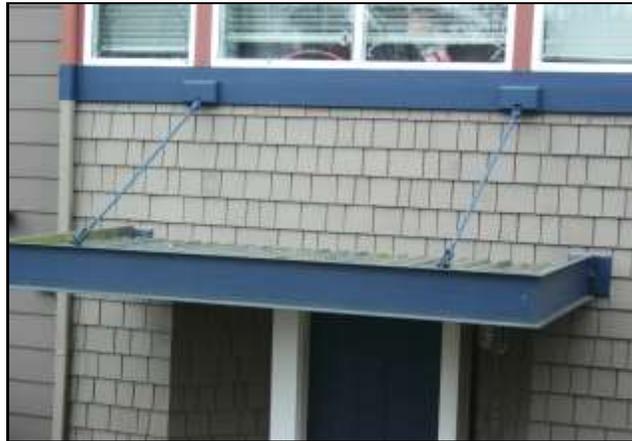
Useful Life:
8 years

Remaining Life:
7 years

\$425/unit (x48 units), Lower allowance for mid-way touch-up caulk/paint project

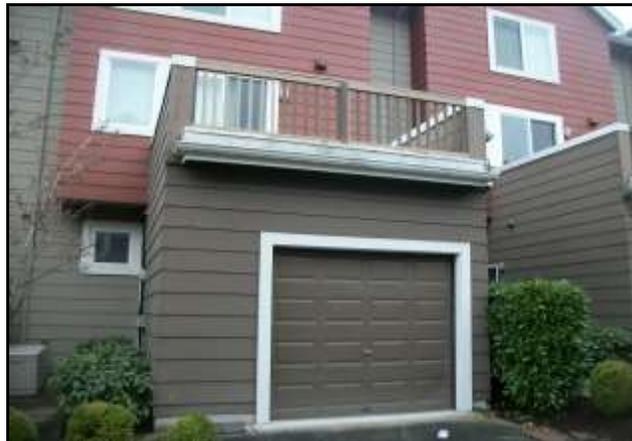
Useful Life:
5 years

Remaining Life:
0 years

\$6/Sq Ft, Lower estimate to clean, prime and seal/top coat

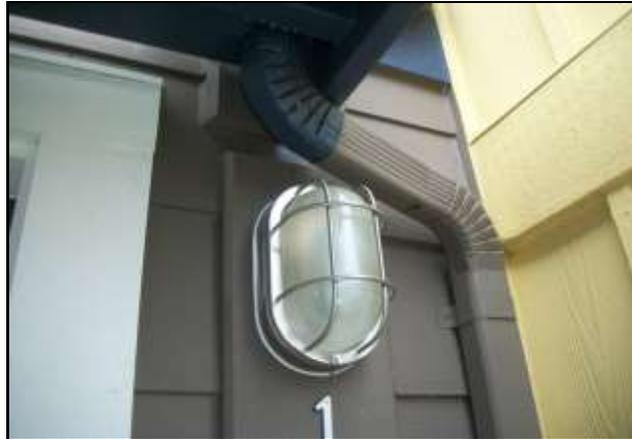
Useful Life:
24 years

Remaining Life:
11 years

\$100/each (x100), Lower allowance to remove and replace
