Update “With Site-Visit” Reserve Study

Villaggio Neighborhood Issaquah, WA

Report #: 21948-5
For Period Beginning: July 1, 2016
Expires: June 30, 2017

Date Prepared: January 12, 2016

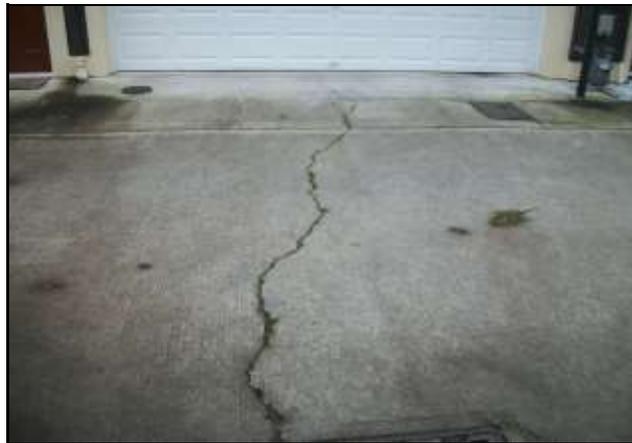
History : No major repairs known

Useful Life:
5 years

Remaining Life:
0 years

Best Case: \$3,800

Worst Case: \$6,100

Lower allowance for partial repair

Higher allowance; more repair needs

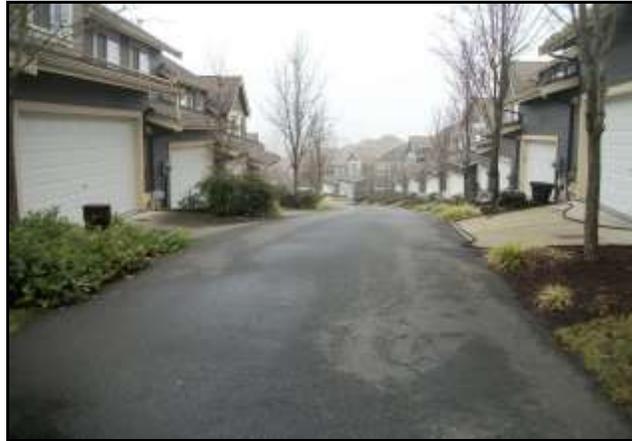
Useful Life:
30 years

Remaining Life:
19 years

Best Case: \$7,800

Worst Case: \$9,600

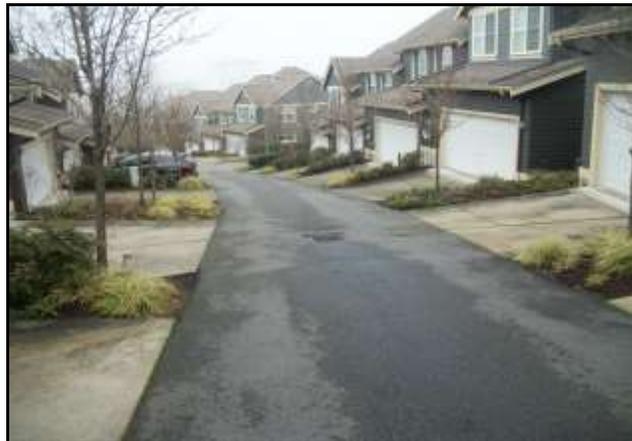
Comp # : 121 Asphalt - Repair/Sealcoat Quantity: ~4,000 GSF

Useful Life:
5 years

Remaining Life:
0 years

Best Case: \$1,800

Worst Case: \$2,300

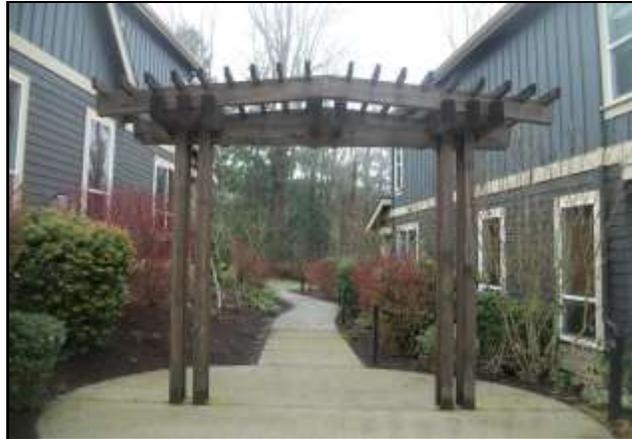
Useful Life:
20 years

Remaining Life:
8 years

Best Case: \$2,500

Worst Case: \$3,000

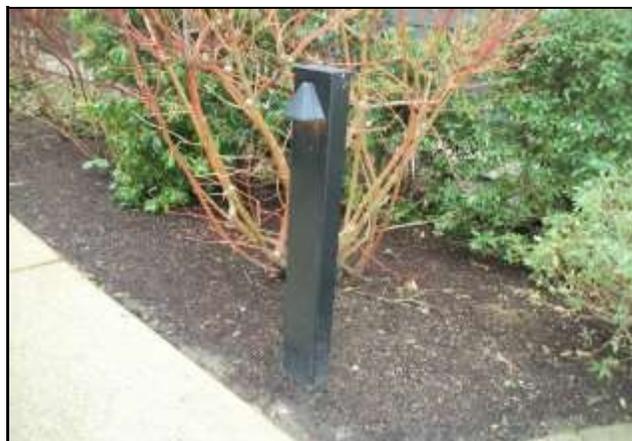
Useful Life:
20 years

Remaining Life:
8 years

Best Case: \$1,600

Worst Case: \$2,200

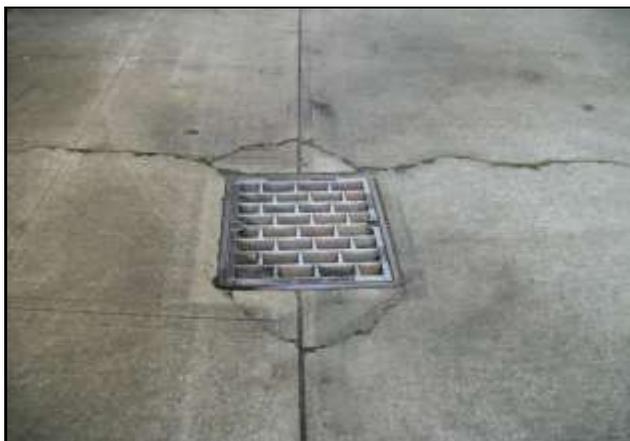
Useful Life:
5 years

Remaining Life:
4 years

Best Case: \$6,500

Worst Case: \$7,100

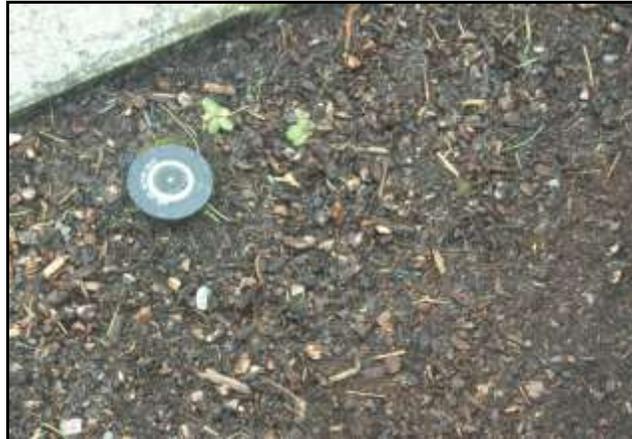
Useful Life:
5 years

Remaining Life:
1 years

Best Case: \$3,300

Worst Case: \$5,500

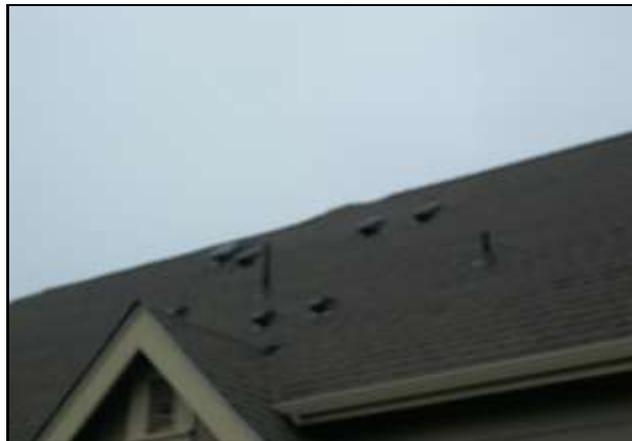
Useful Life:
25 years

Remaining Life:
5 years

Best Case: \$302,000

\$4/Sq Ft, Lower allowance to tear off and reroof

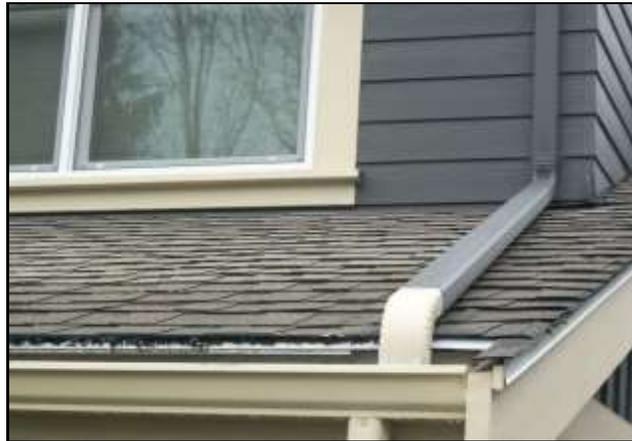
Useful Life:
3 years

Remaining Life:
0 years

Best Case: \$18,500

Worst Case: \$22,700

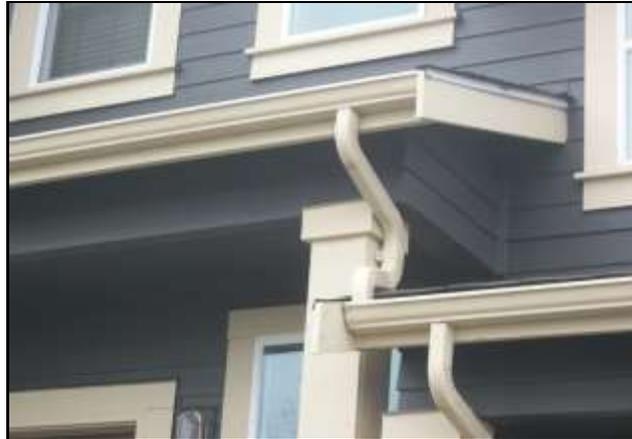
Useful Life:
25 years

Remaining Life:
13 years

Best Case: \$39,900

\$5.50/Linear Ft, Lower allowance to remove and replace

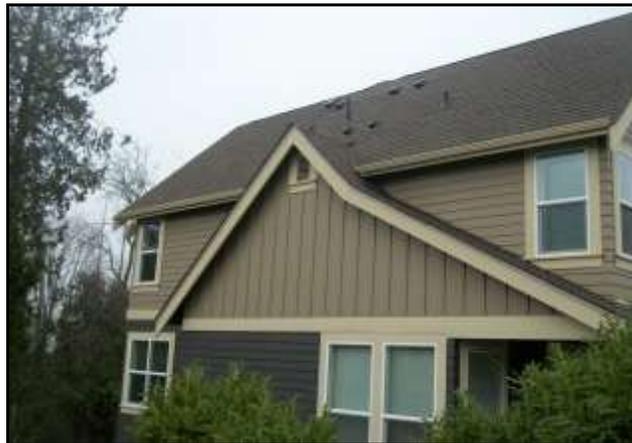
Useful Life:
8 years

Remaining Life:
5 years

Best Case: \$6,500

Worst Case: \$10,500

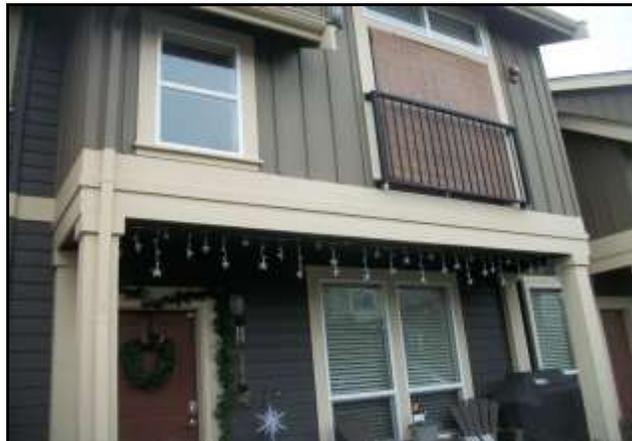
Useful Life:
8 years

Remaining Life:
5 years

Best Case: \$95,500

\$2,000/unit (x50 units), Lower allowance to repaint all exterior building surfaces

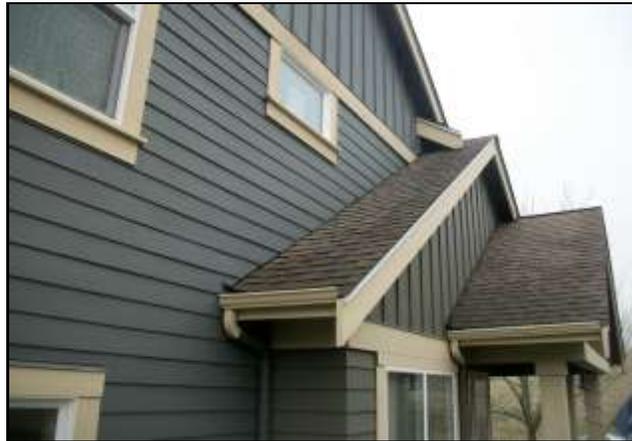
Useful Life:
8 years

Remaining Life:
1 years

Best Case: \$32,800

\$600/unit (x50 units), Lower allowance to paint trim areas including decks, awnings, belly bands, etc.

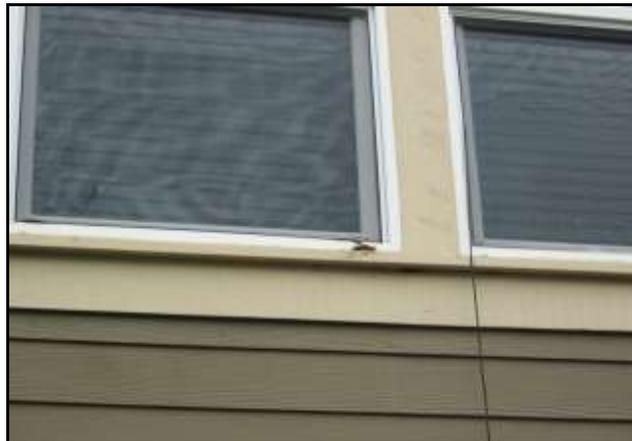
Useful Life:
4 years

Remaining Life:
3 years

Best Case: \$3,800

Worst Case: \$6,000

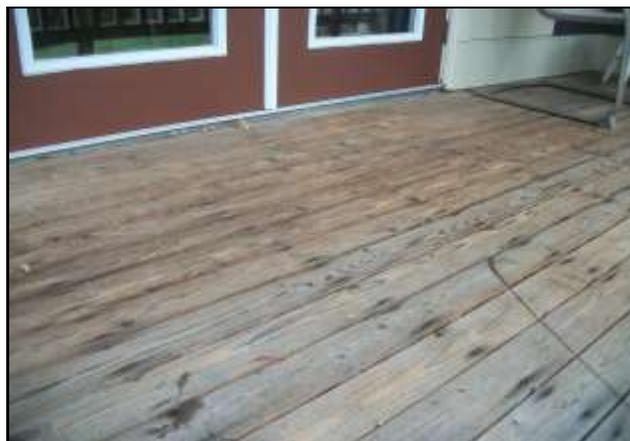
Useful Life:
20 years

Remaining Life:
8 years

Best Case: \$40,000

Worst Case: \$50,000

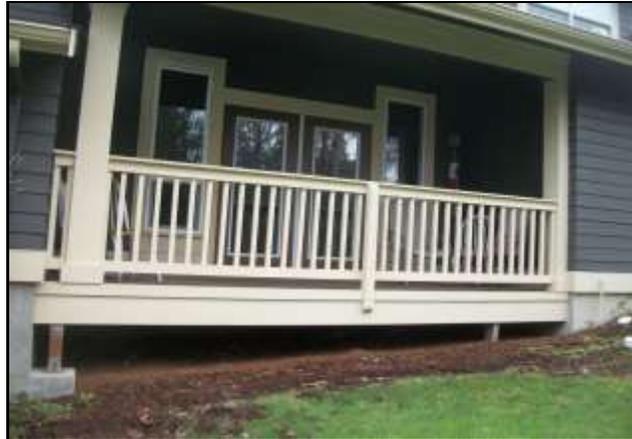
Useful Life:
20 years

Remaining Life:
8 years

Best Case: \$11,000

Worst Case: \$13,200

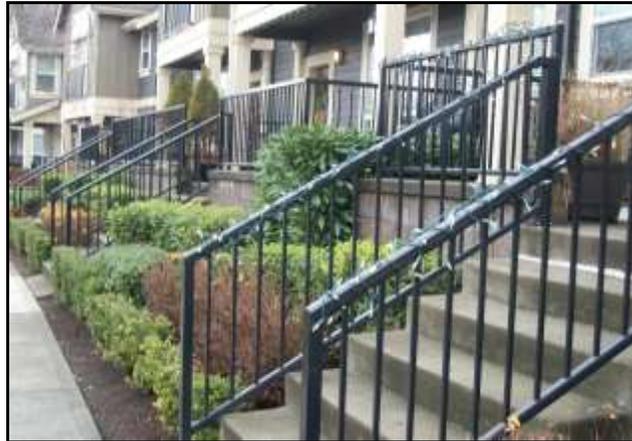
Useful Life:
30 years

Remaining Life:
18 years

Best Case: \$42,400

Worst Case: \$57,800

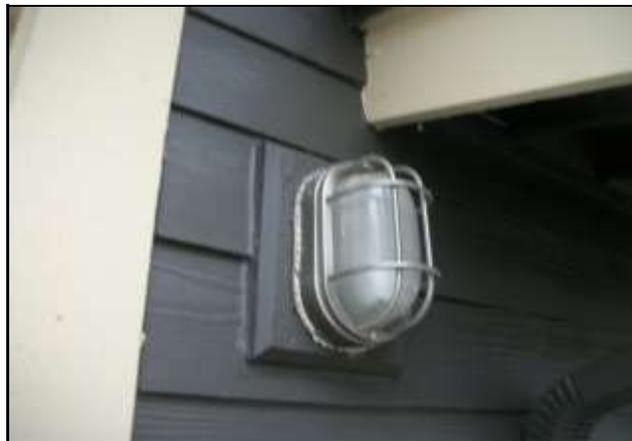
Useful Life:
24 years

Remaining Life:
13 years

Best Case: \$14,300

Worst Case: \$20,800
