Update “With Site-Visit” Reserve Study

Grand Ridge Drive Neighborhood Issaquah, WA

Report #: 16879-4
For Period Beginning: July 1, 2016
Expires: June 30, 2017

Date Prepared: January 18, 2016

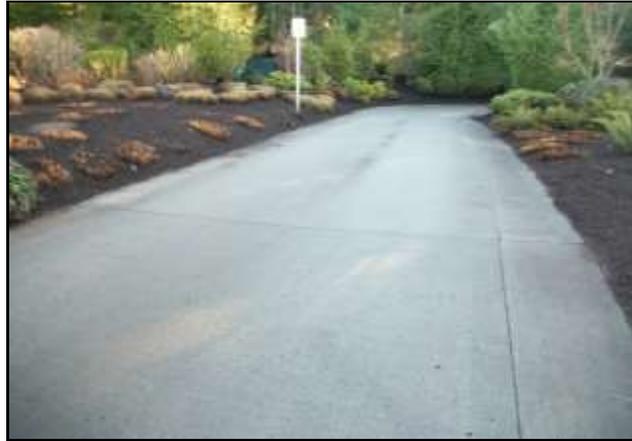
Comp # : 103 Concrete - Repair/Replace Quantity: ~10,000 GSF

Evaluation : As with our last inspection, although some local grime/dirt, we noted stable condition with no significant damage/deterioration observed. Repair any trip and fall hazards (1/2" or larger displacement) immediately to ensure safety. Although larger repair/replacement expenses can emerge as the community ages, difficult to predict timing, cost and scope with no basis for reserve funding at this time. Adjust as conditions, actual expense history indicates within future reserve study updates. As routine maintenance, inspect regularly, pressure wash for appearance and repair promptly as needed to prevent water penetrating into the base and causing further damage. Monitor tree roots nearby; consult with arborist for best practice. The stamped/decorative areas at the bridge sidewalks can be sealed to improve appearance.

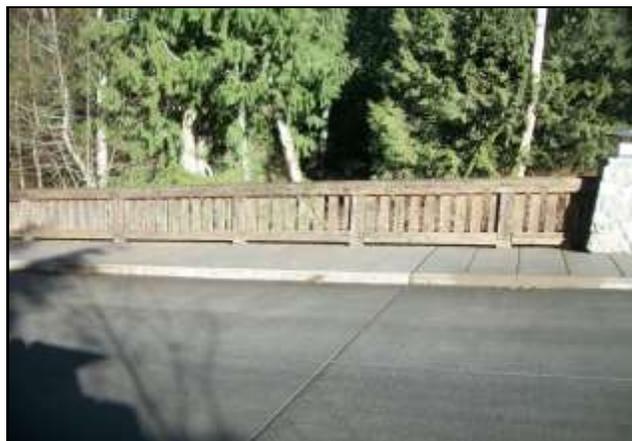
Comp # : 112 Bridge - Repair/Replace Quantity: Approx 22' x 96'

Evaluation : No obvious issues noted and no problems readily visible at this time; concrete, masonry block and asphalt roadway bridge. We assume properly designed and constructed. Regular inspections by engineer are prudent; factor those inspections and general repairs within operating budget. Assuming proactive maintenance, no predictable basis for reserve funding at this time for bridge and underlying culvert pipe. Track expenses and engineer's recommendations for basis of adjustment in reserve study updates in future years. Inspect regularly and factor local repairs within the general maintenance operating budget.

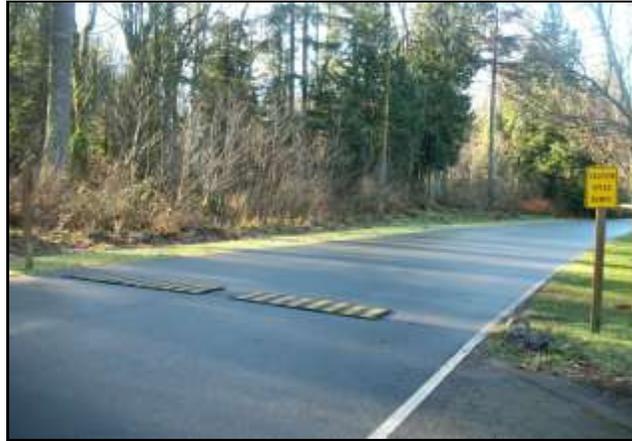
Evaluation : As with our previous site visit, stable surface condition noted with no significant raveling (loss of binder) damage or deterioration observed. Although regular seal coat cycles can provide protection from the oxidizing effects of weather, these type of roadways are generally not seal coated due to difficulty with mobilization, feasibility for a project of this size and overall cost/benefit ratio. However, we are recommending funding for periodic repairs (see # 202). Even with ordinary care and maintenance, plan for eventual large scale resurface/overlay at roughly the time frame below. As timing draws nearer, consult with asphalt vendor/consultant for recommendations and complete scope. As routine maintenance, keep roadway clean, free of debris and well drained; fill/seal cracks (hot rubberized crack fill) to prevent water from penetrating into the sub-base and accelerating damage.

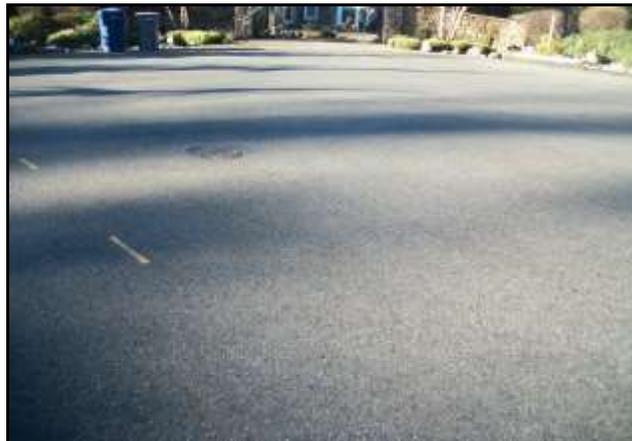
Comp # : 202 Asphalt - Periodic Repairs/Repl. Quantity: Approx 182,000 sq ft

Evaluation : Asphalt appears to be in good condition at this time with no cracks, raveling, alligating or other damage/deterioration observed. Although regular cycles of seal coating can protect the pavement from the deteriorating effects of sun and water, sealcoating is most common in places such as parking lots and low speed driveway accesses. We assume the roadways here are constructed to shed water. While asphalt seal coating is not funded for here, best to plan for periodic funding for larger repairs/replacement that might be needed prior to anticipated large scale resurface/overlay project (#201). We have extended the remaining useful life here based on the condition and construction is not complete in this community. The timing/pricing here can vary and to be used as placeholders. As part of routine maintenance, inspect regularly, fill cracks and clean oil stains promptly in between cycles as routine maintenance. Keep roadways clean and free of debris.

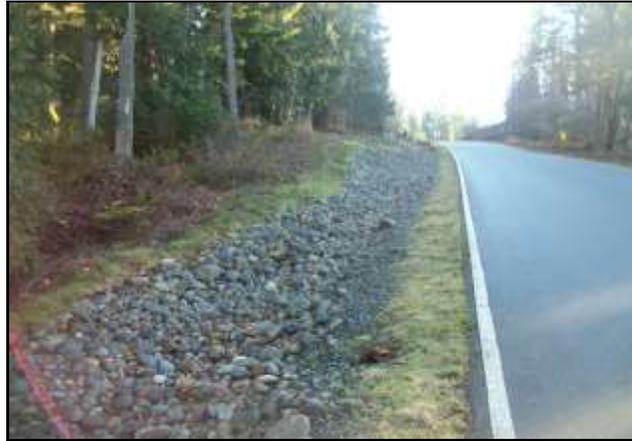
Comp # : 210 Drainage/Culverts - Repair/Replace

Evaluation : As with our previous reserve study site visit, no problems observed and none reported of roadside culvert areas or bio-swales throughout community. In the past, reported that the two drains near the park/open space were cleaned, however cost less than \$500 and funded from operating budget. We assume to be properly designed and constructed. Drainage facilities are typically inspected periodically by governing authority; typically storm system maintenance guidelines can be found on their website. Although annual work should be performed as part of general maintenance operating funding, we recommend including a funding allowance for periodic larger expenses that might occur. Track expenses and adjust in reserve study updates as needed. As part of routine maintenance, inspect regularly and clean/repair/replace locally as needed.

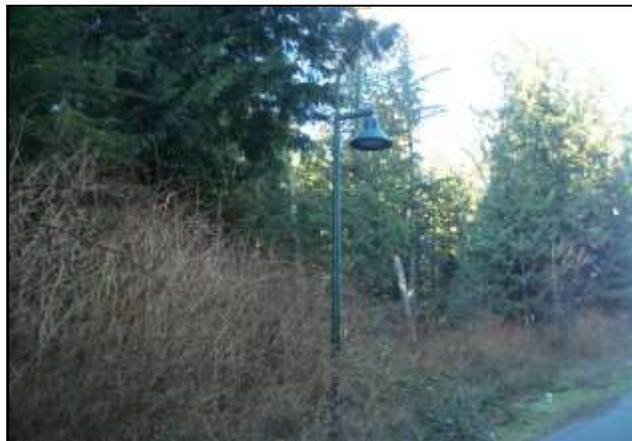
Comp # : 320 Street Lights - Replace

Evaluation : Street lights are the responsibility of Intolight/PSE to maintain, repair and replace. With this understanding, no reserve funding needed

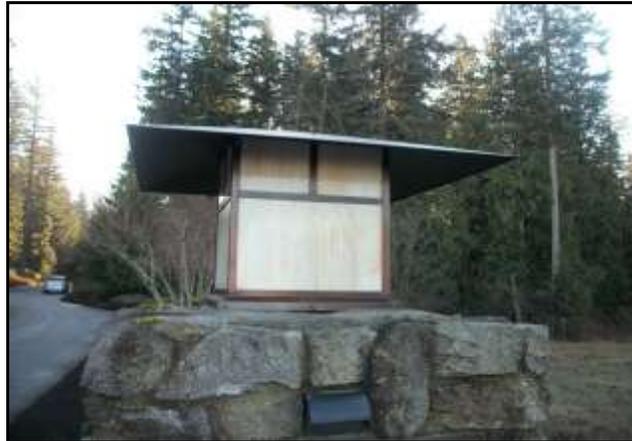
Comp # : 324 Bridge Lights - Repair/Replace Quantity: (6) post lights

Evaluation : We did not observe any visible signs of problems during our daylight inspection. In the past, Association Management reported cost for bulb replacements is high. Best to plan for large scale replacement at roughly the time frame below for cost efficiency and consistent quality/appearance in these visible community areas. As routine maintenance, inspect, repair/change bulbs as needed.

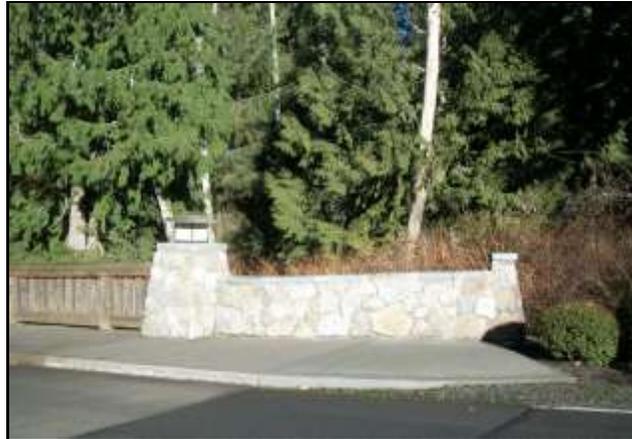
Comp # : 501 Masonry - Clean/Seal/Repair Quantity: ~1,500 GSF, stone

Evaluation : Some local wear/deterioration, however no major damage noted such as cracking, settling, etc. Key to long lasting performance is original proper design and installation with adequate base and surrounding drainage. Although difficult to predict timing, cost and scope, we recommend a periodic funding allowance for repairs/refurbishing (cleaning/sealing) of stone walls at bridge to maintain appearance of these highly visible common areas. As part of routine maintenance, inspect regularly and repair as needed from operating budget.

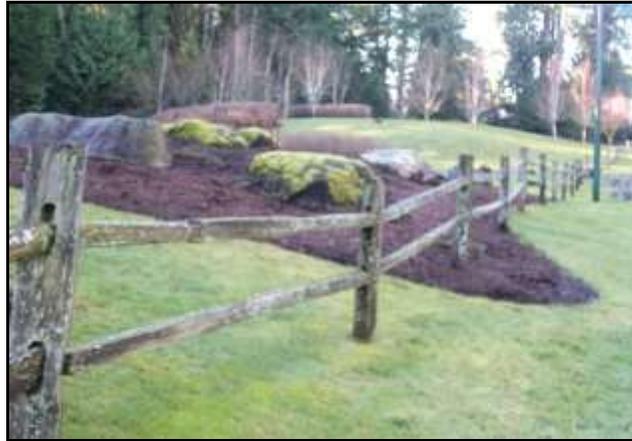
Comp # : 505 Split Rail Fence - Replace

Evaluation : Weathered, grayed appearance with some leaning but no widespread damage noted. Although stain can be applied to improve appearance/provide protection, not common at these type of fences which are typically left to weather naturally. Plan to replace at roughly the time frame below with funding included here for similar style fence. At next replacement, association might want to consider replacing with lower maintenance products like composite, vinyl, etc; typical costs at installation about 40 to 50% higher, but requires less maintenance and has significantly longer life. As routine maintenance, inspect regularly for any damage, repair as needed and avoid contact with ground and surrounding vegetation.
